Water Management at the Closed Brenda Mine – Reviewing a Decade of Performance

Ron Nicholson, EcoMetrix Incorporated

19th ANNUAL BRITISH COLUMBIA-MEND ML/ARD WORKSHOP

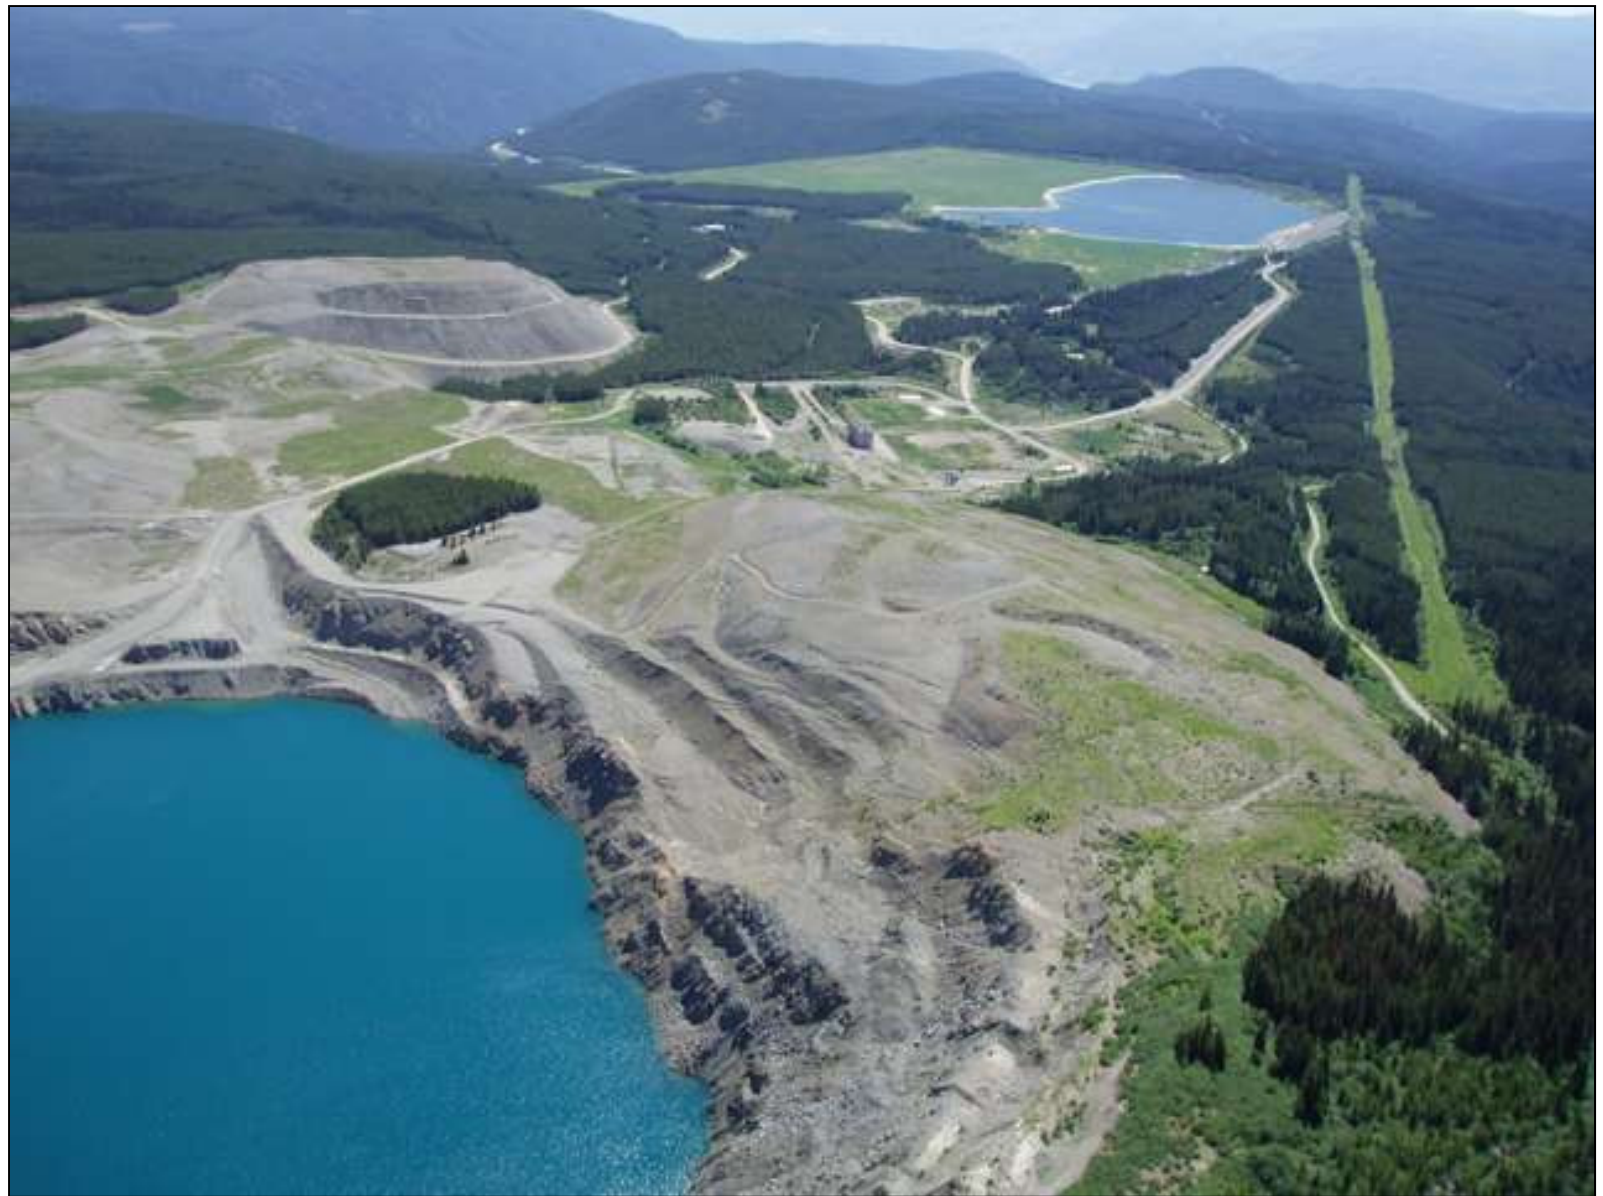
Brenda – Open Pit

- 1050 m x 980 m
- maximum depth of 370 m
- Current operating water depth is approx. 160 m or about 33 m below lowest point of pit rim
- Current water storage of about 35 Mm³ with 52 Mm³ capacity

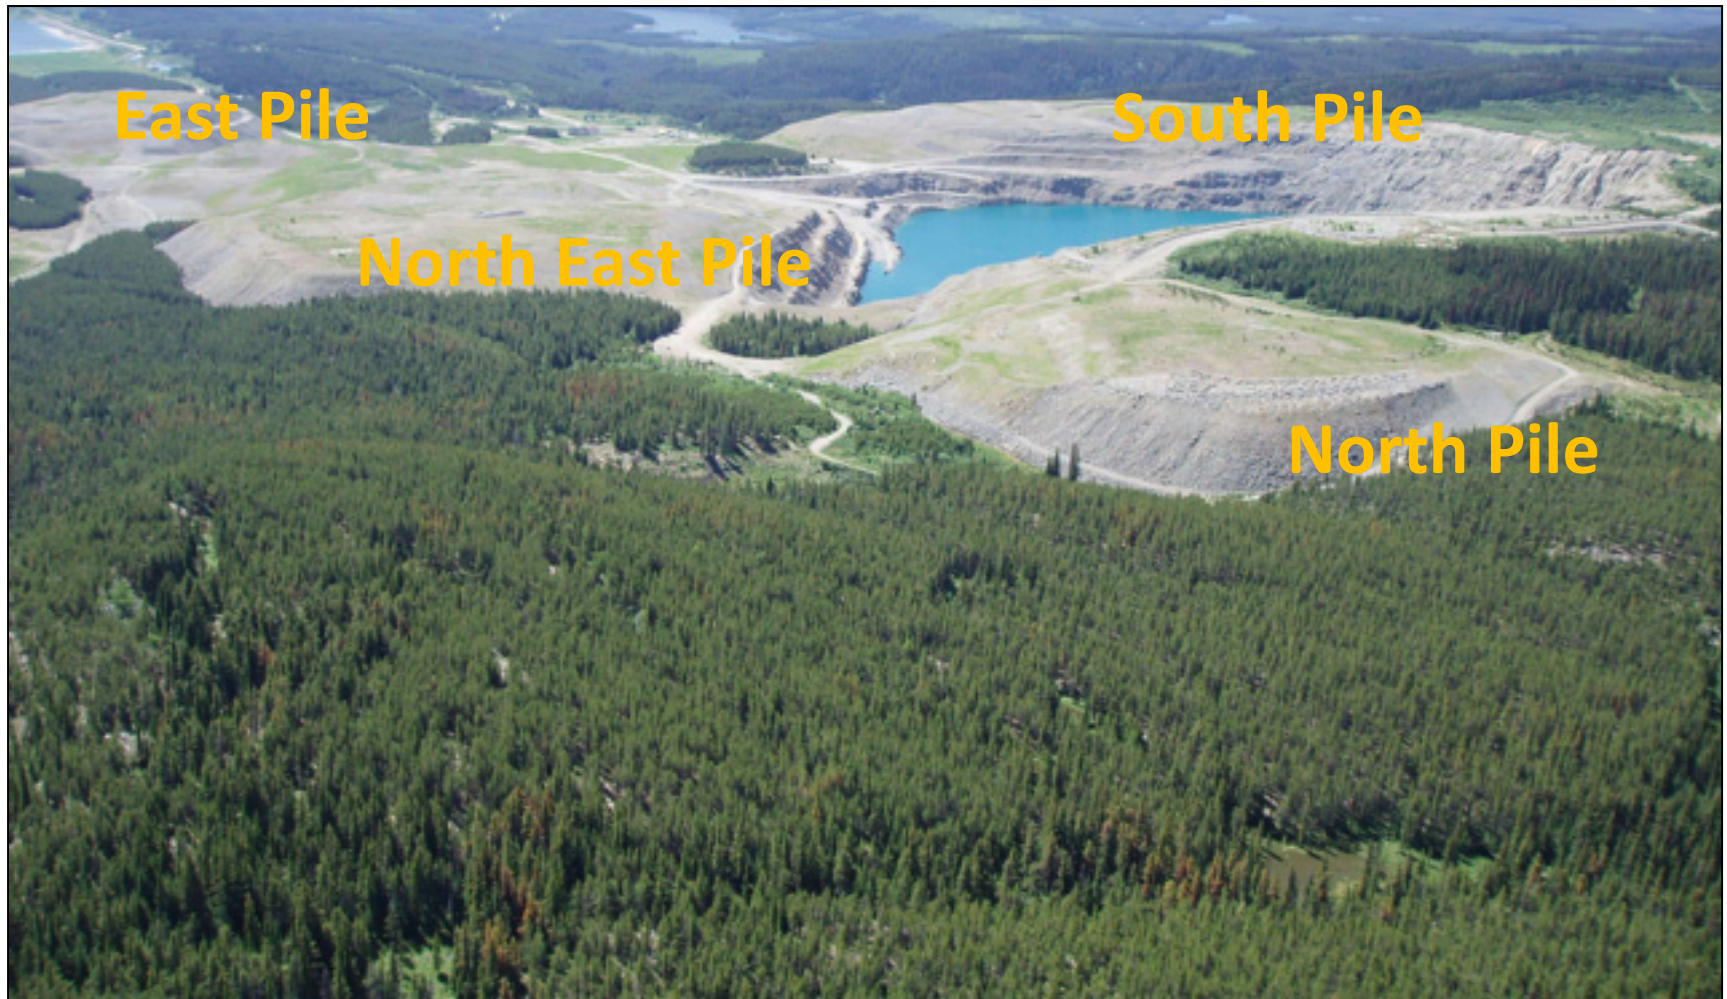
Brenda – Rock Stockpiles

- Four rock piles (N, NE, E and S)
- Approx. 109 Mt
- Built in 20 m lifts
- Stable and suitable for wildlife habitat

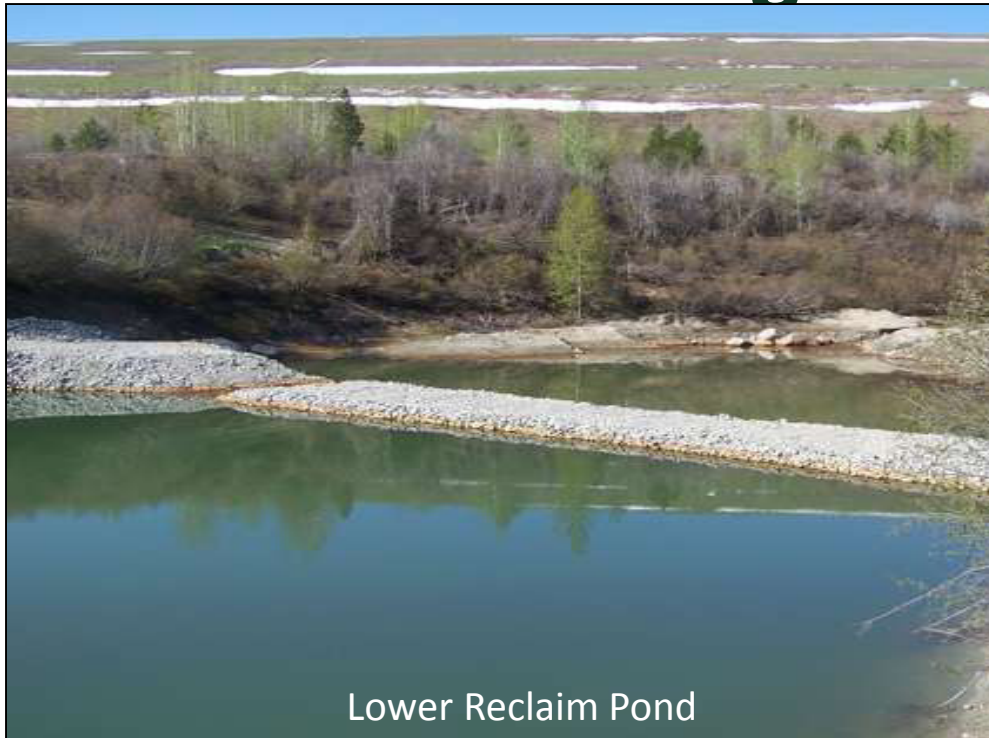
Brenda – Tailings

- Seepages through dams are contained and sent to the tailings pond to prevent release of untreated water to environment
- Seepage flow rates and quality are monitored

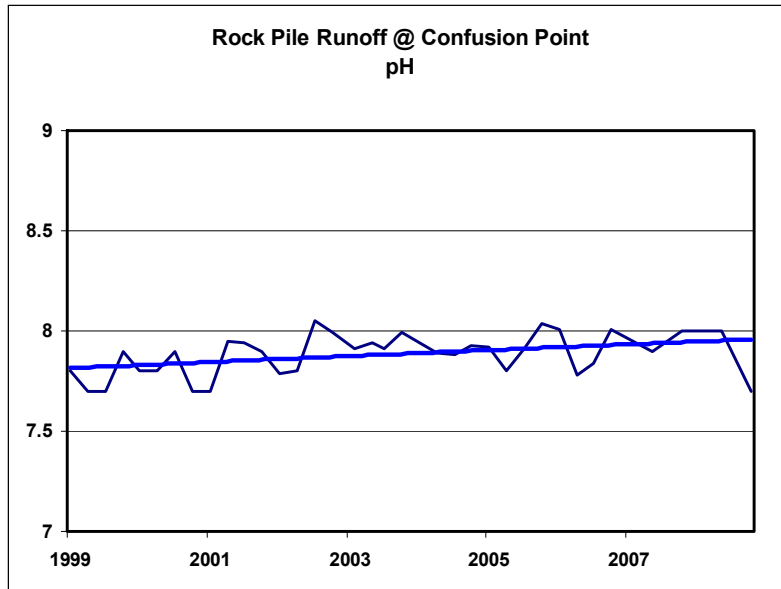
Drainage Quality from Rock Piles

pH

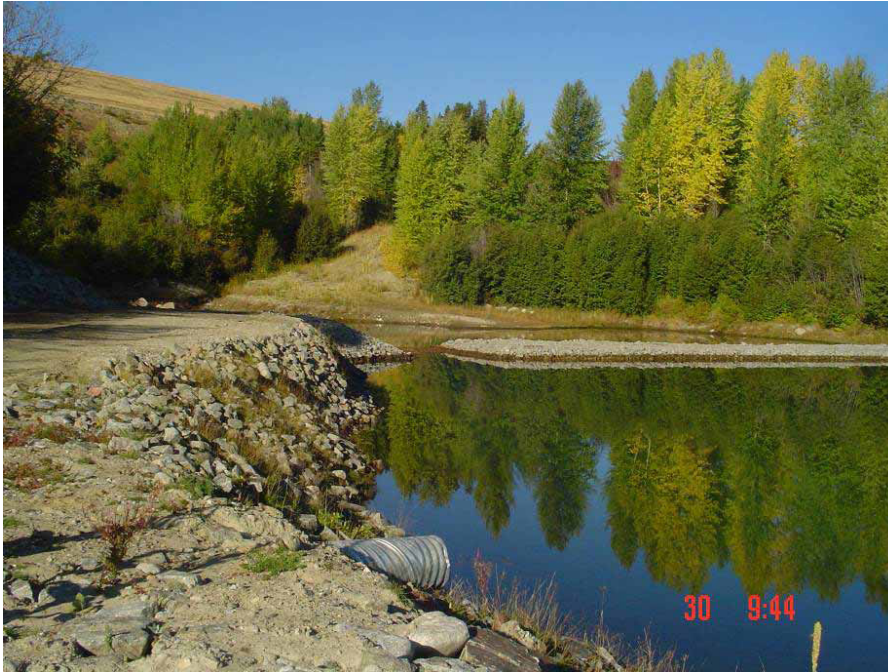
Brenda – Water Management

Lower reclaim pond looking up to main dam

- Tailings pond and open pit used for active storage of collected water
- Seepage waters collected, returned to tailings pond and treated seasonally before release
- 2 to 3 Mm³ treated annually

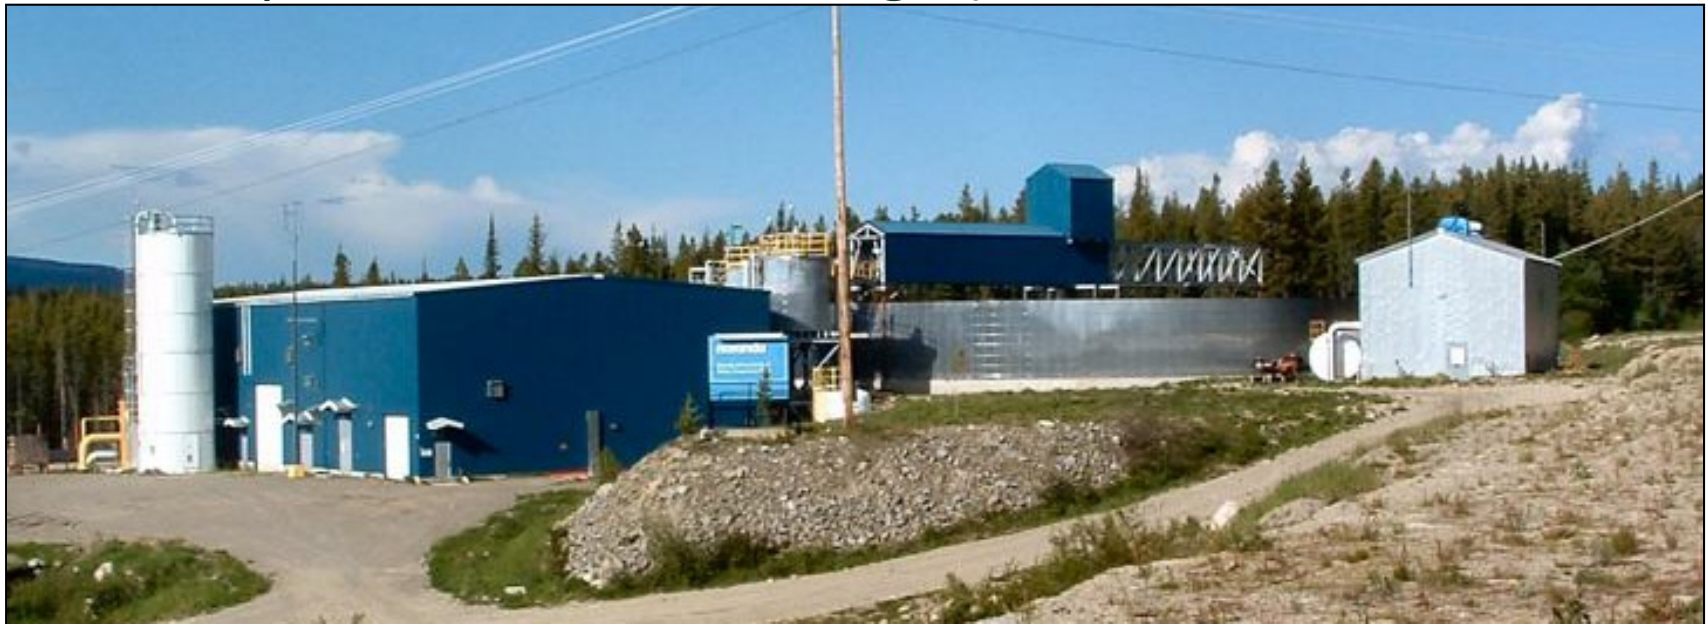
Brenda – Water Management

- Average Influent Mo = 2.75 mg/L
- Treatment plant consistently discharges water with concentrations averaging 0.05 mg/L (much lower than permit level of 0.25 mg/L)

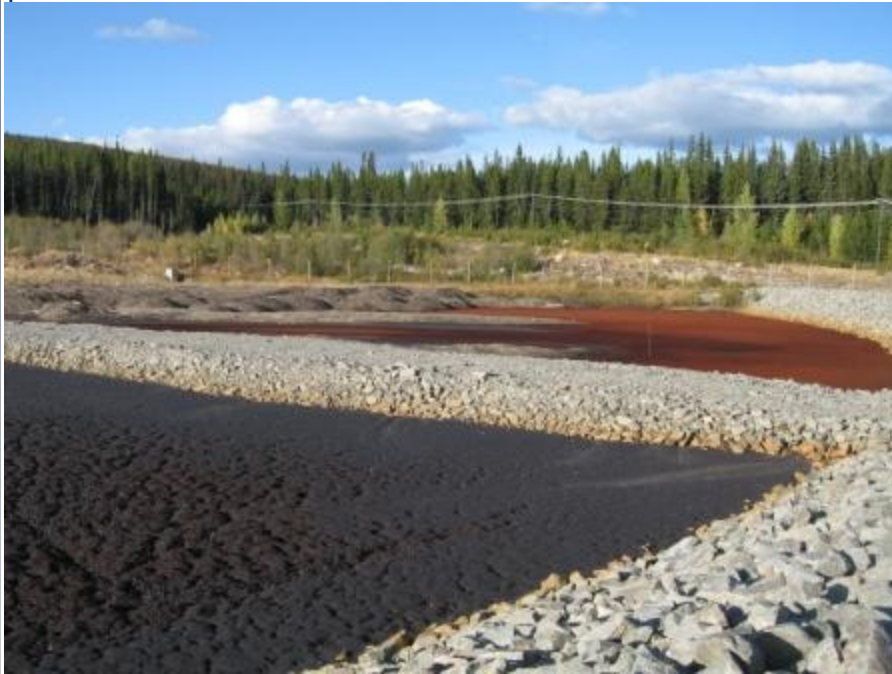
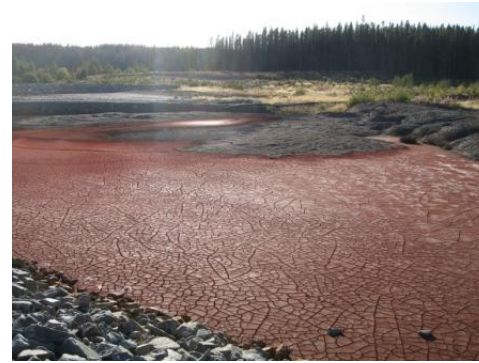
Brenda – Water Management

Treatment solids (sludge)
in containment cells

- Water treatment solids (sludge) stored in engineered impoundment in catchment with flow reporting to tailings pond
- Designed to dewater and drain in order to consolidate solids
- Sludge drainage water goes to tailings pond
- Impoundment can be increased in size as required over time and will remain within catchment of tailings pond

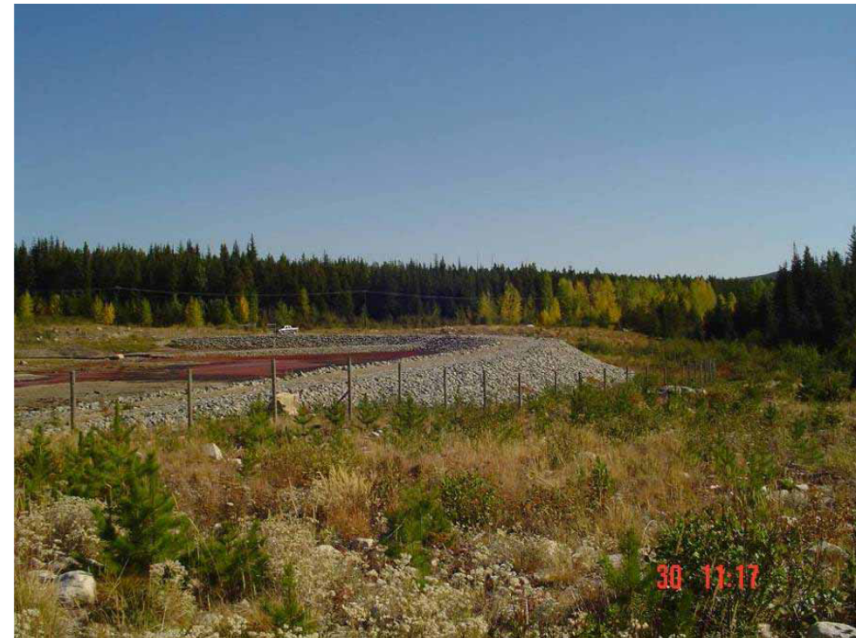
Dewatered
treatment
solids

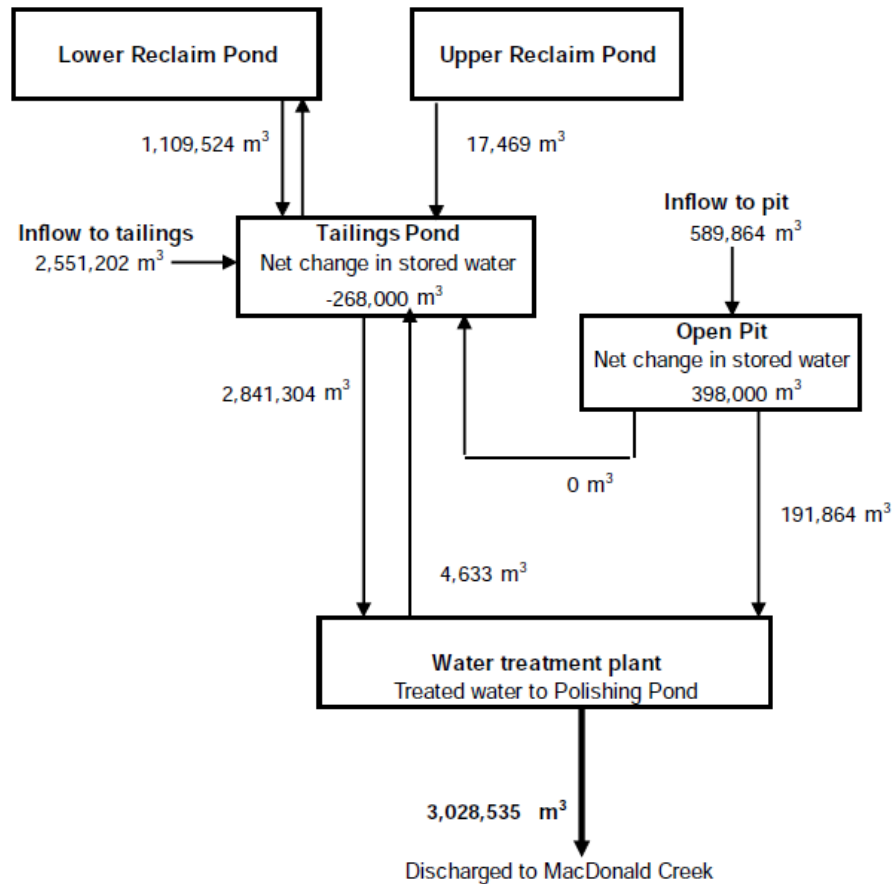
Water Management

All seepage reports to tailings pond

2011 Water Flows

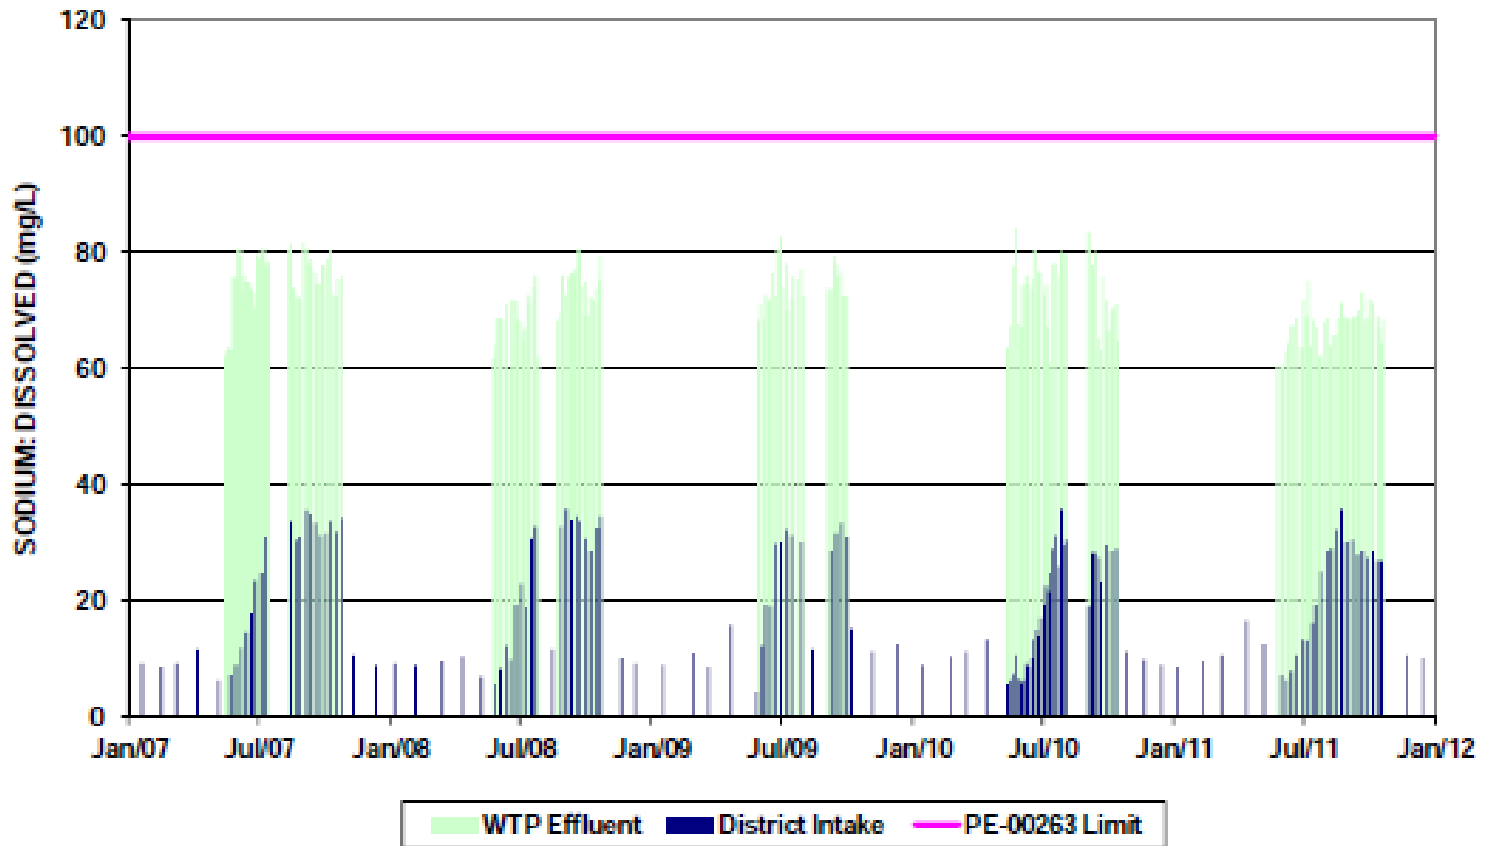
Effluent and Downstream Concentrations of Sodium

Trepanier Creek at District Intake (Station 7) and Effluent Discharge (Station 22)
Dissolved Sodium
2007 through 2011

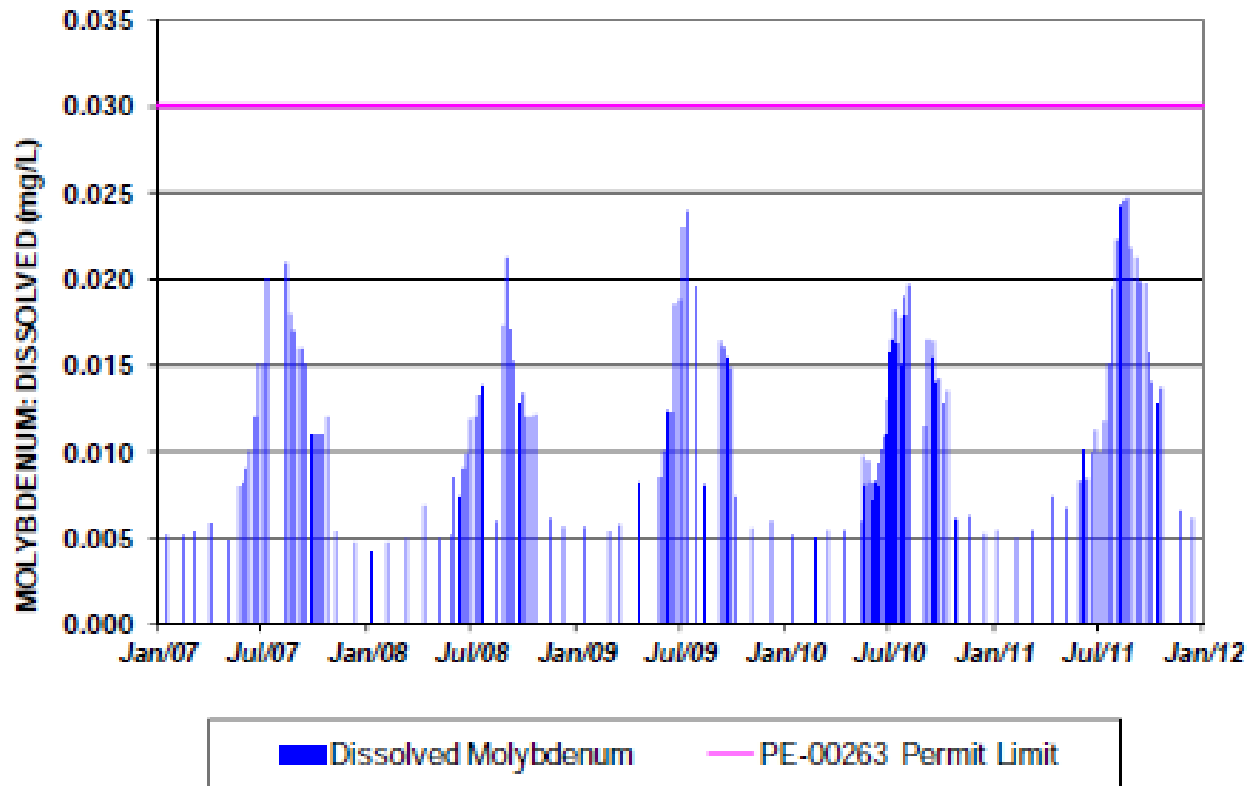
Molybdenum Downstream

Trepanier Creek at District Intake (Station 7)
Dissolved Molybdenum
2007 through 2011

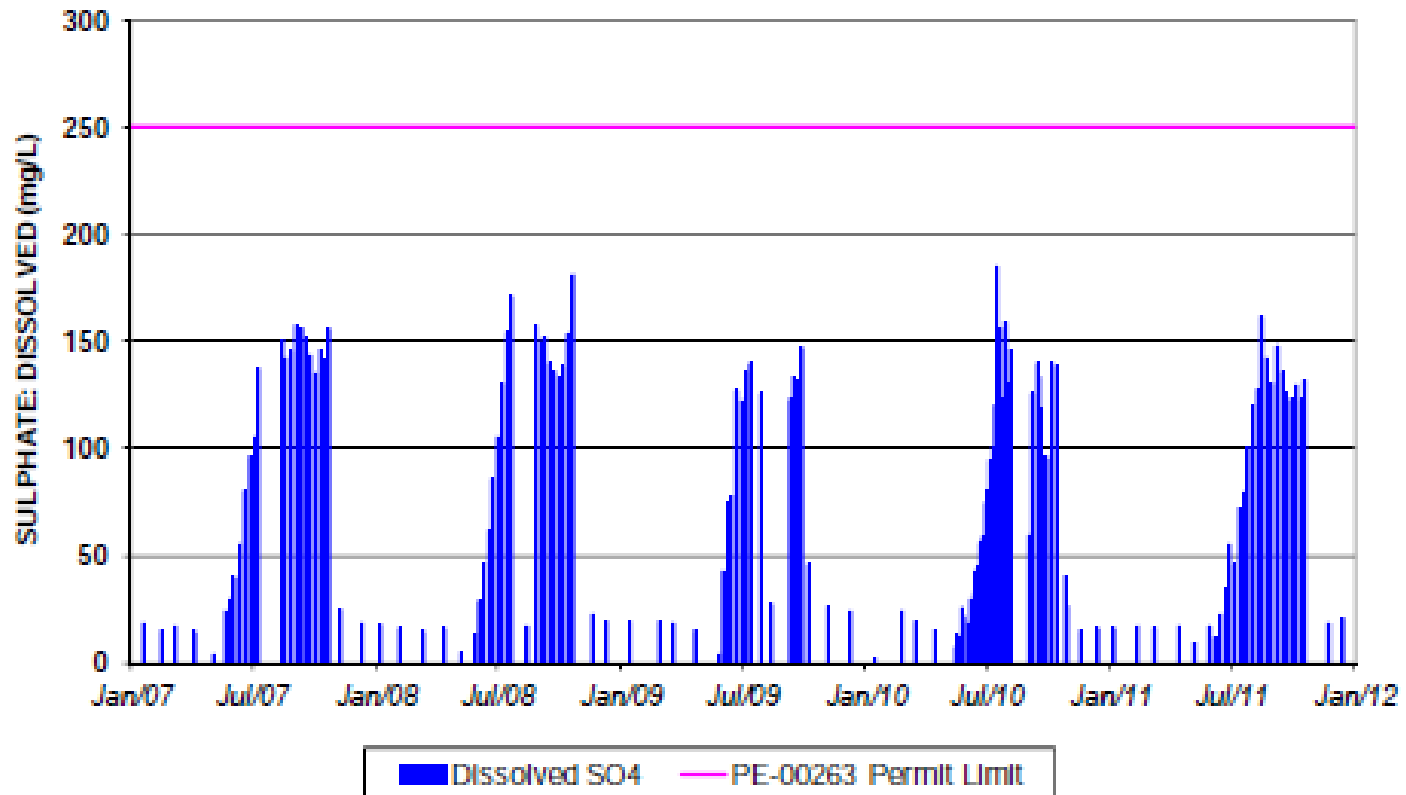
Sulphate Downstream

Trepanier Creek at District Intake (Station 7)
Dissolved Sulphate
2007 through 2011

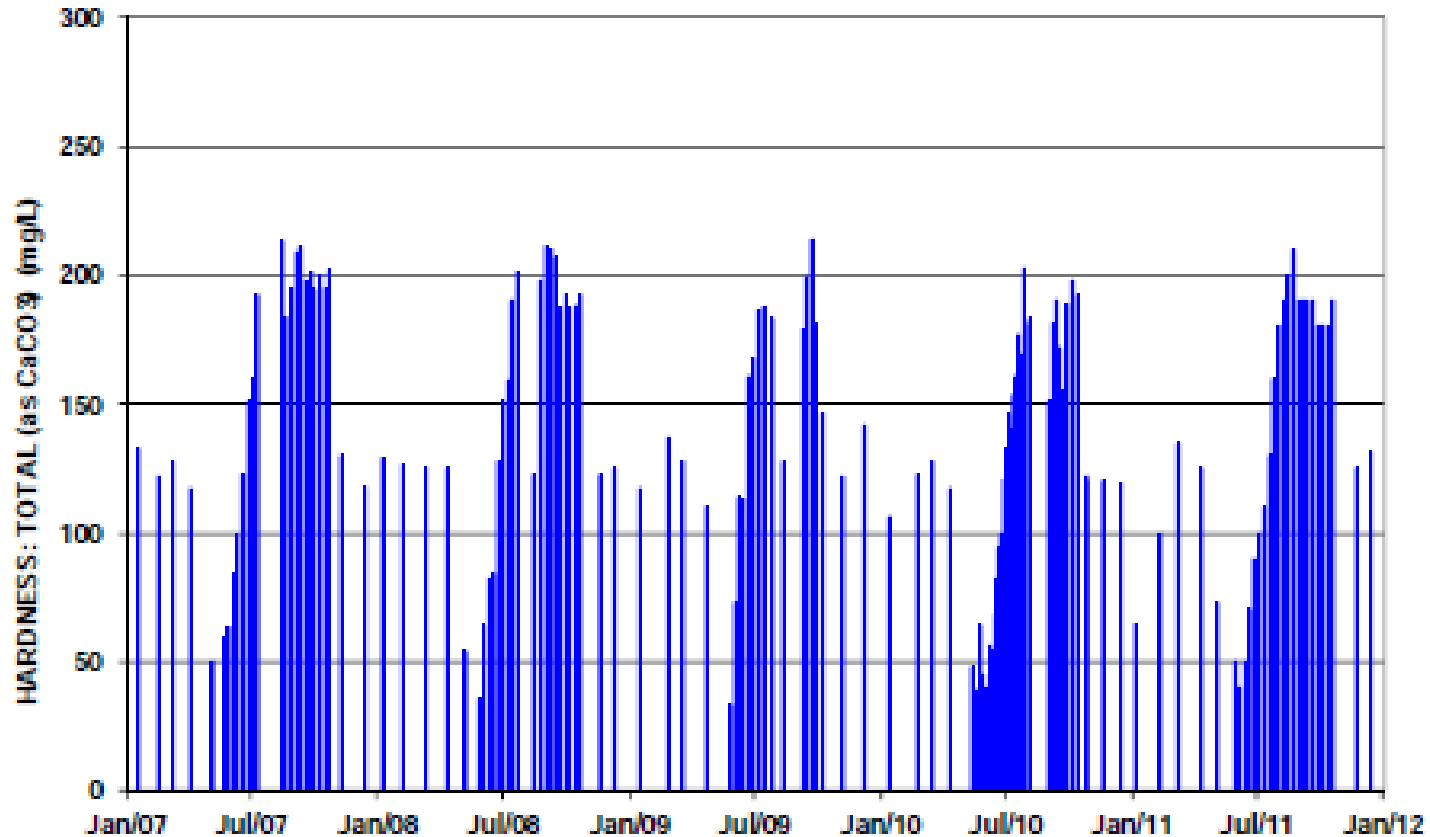
Hardness Downstream

Trepanier Creek at District Intake (Station 7)
Hardness
2007 through 2011
