GMB and GCL covers: construction, maintenance, monitoring, repair and replacement

R. Kerry Rowe FRS, FREng, FRSC, FCAE

**Professor and Canada Research Chair in
Geotechnical and Geoenvironmental Engineering**

Queen's University
Kingston
Canada
www.geoeng.ca

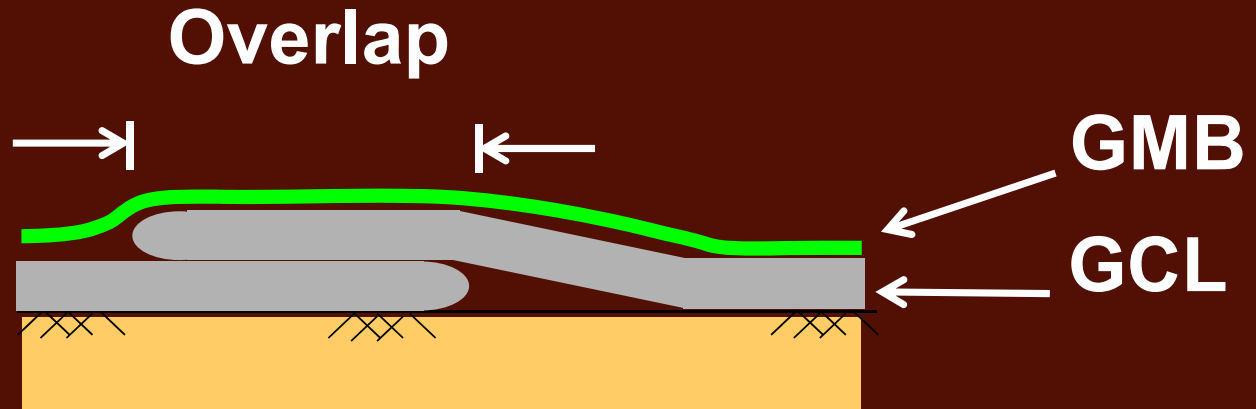
Overlap

If you cover the liner as per manufacturers' guidelines this is how it will remain –
BUT if you leave the composite liner uncovered you may get:

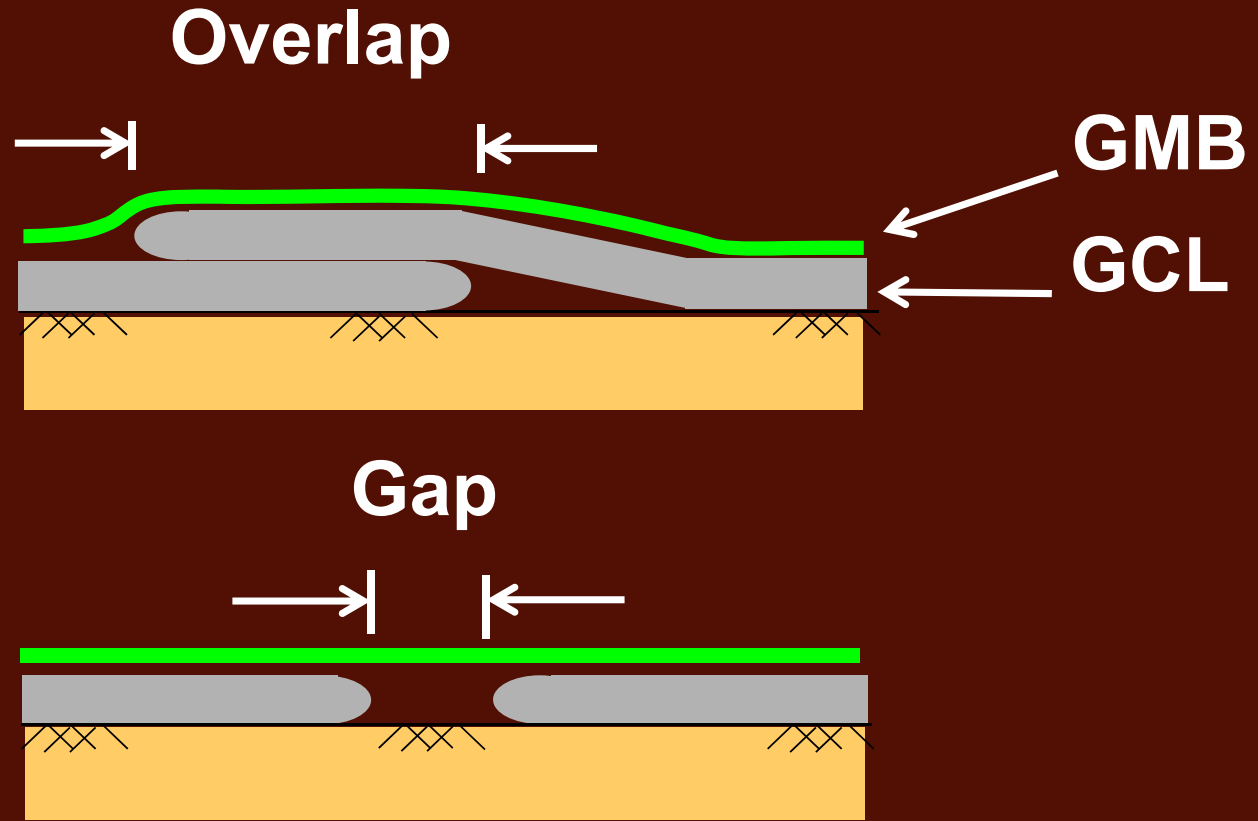
Overlap loss due to shrinkage

Observed Field Shrinkage

(Thiel et al. 2006)

GCL	Slope	Maximum separation (gap) (mm)	Exposure period (months)
GCL3	18°	200	15
GCL3	4°	300	2
GCL4	34°	1200	36
GCL4	18°	300	5
GCL4	4°	450	2

Initial placed overlap: 150 mm

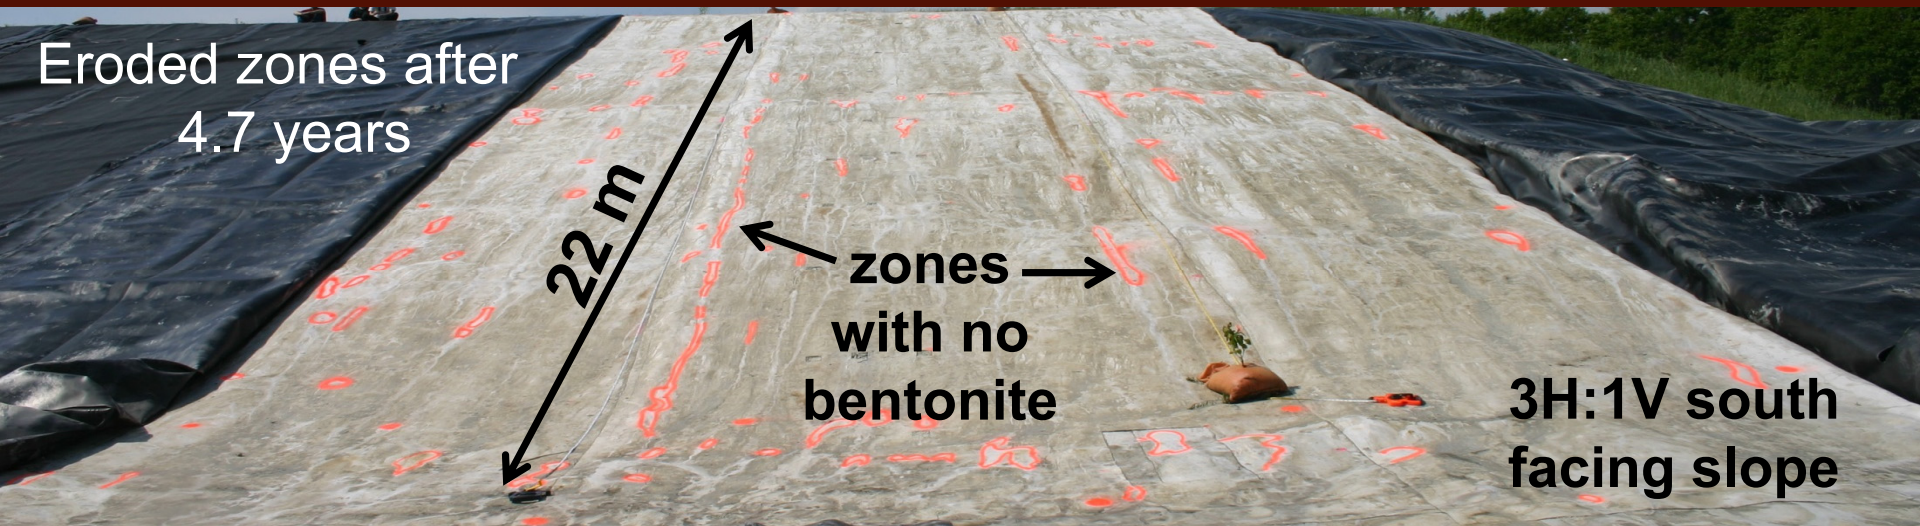
GCLs covered only by a black GMB and left exposed for long periods of time may

- shrink causing loss of overlap, and/or
- experience bentonite migration due to small amounts of condensed water trickling on the GCL below EXPOSED GMB (problem does not occur if GMB is covered by soil)

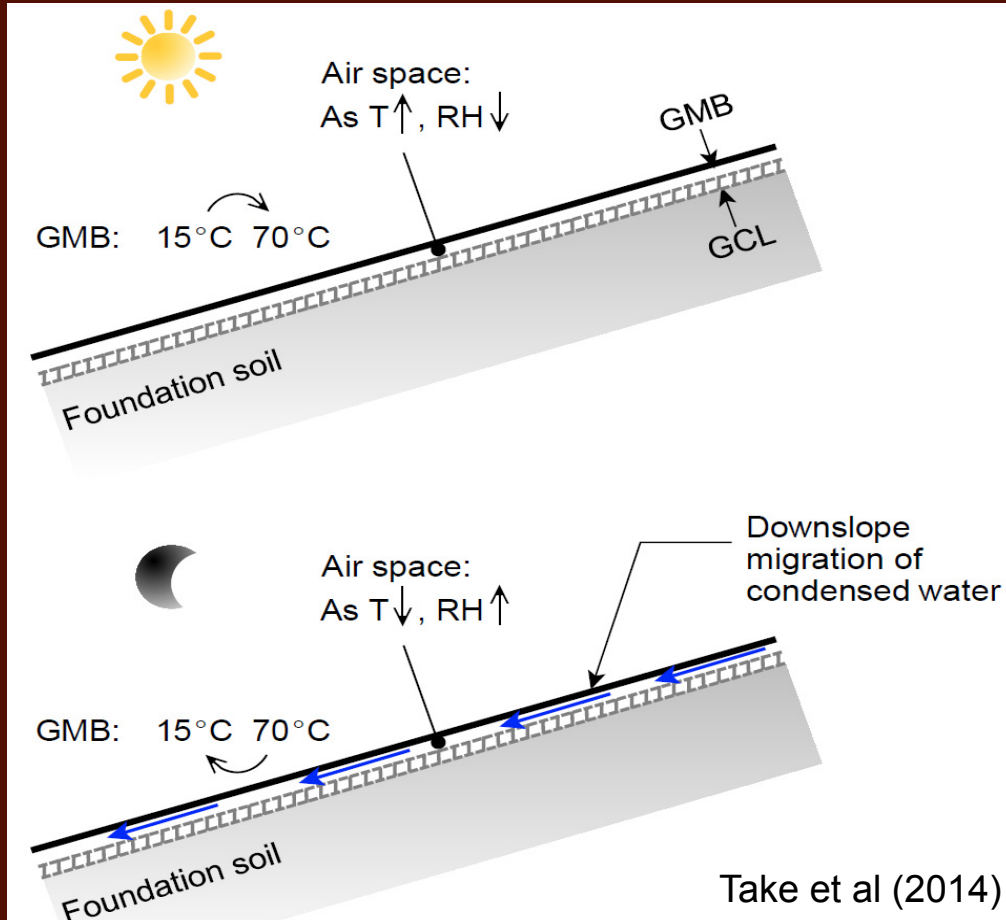
Moisture cycle from thermal cycle when exposed

- GCL hydrates with moisture from subsoil
- on heating:
 - GCL loses moisture to GMB/GCL interface
 - vapour migrates towards wrinkles
- on cooling:
 - vapour condenses on underside of GMB
 - condensed moisture trickles downslope

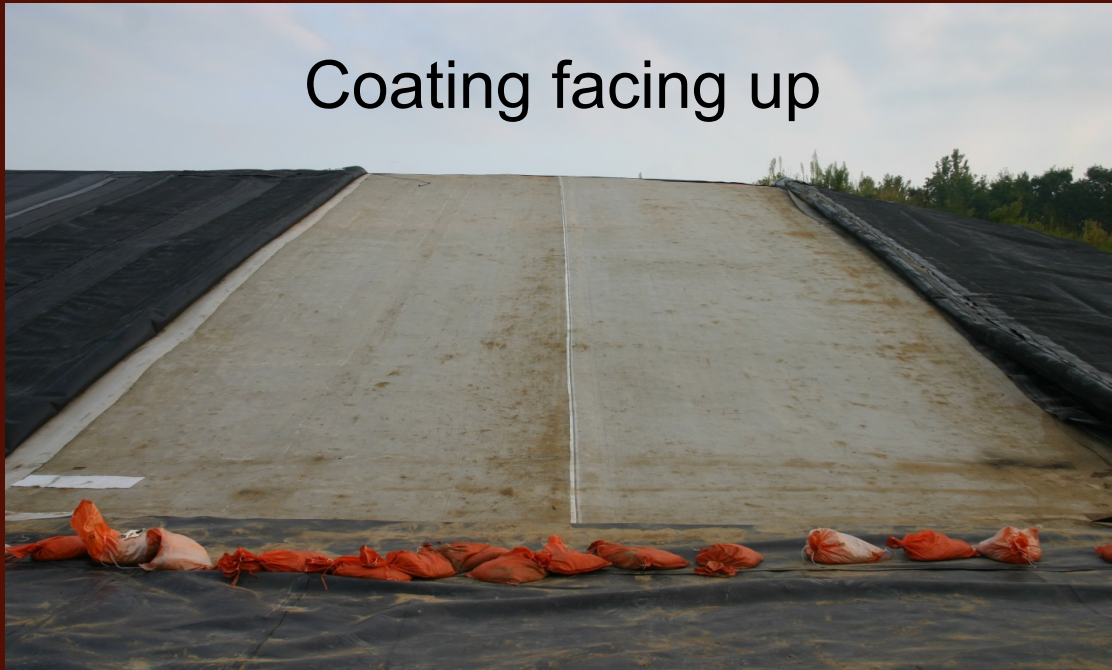
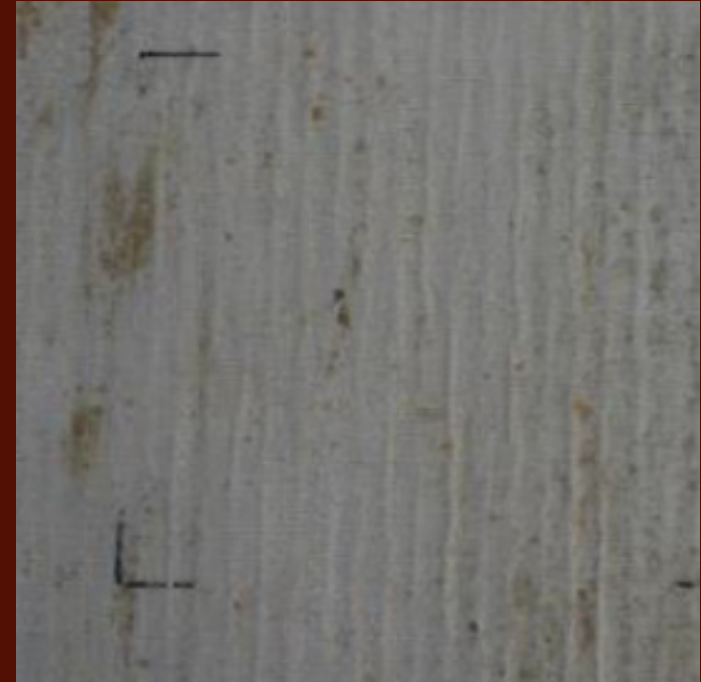
Polymer coated GCL in exposed liner

Upper GTX: Slit-film woven with impregnated polypropylene coating

- no erosion after 28 months
(some other GCLs had significant erosion in this time)
- coating prevented loss of moisture to GMB/GCL interface
