# Previous Mine Waste Disposal and ML/ARD Mitigation at Nyrstar Myra Falls

Paul Ferguson<sup>1</sup>, Christoph Wels<sup>1</sup>, and Nicole Pesonen<sup>2</sup>

<sup>1</sup>Robertson GeoConsultants Inc.  
<sup>2</sup>Nyrstar Myra Falls (Environment Department)

November 30<sup>th</sup>, 2017  
24<sup>th</sup> MEND ML/ARD Workshop

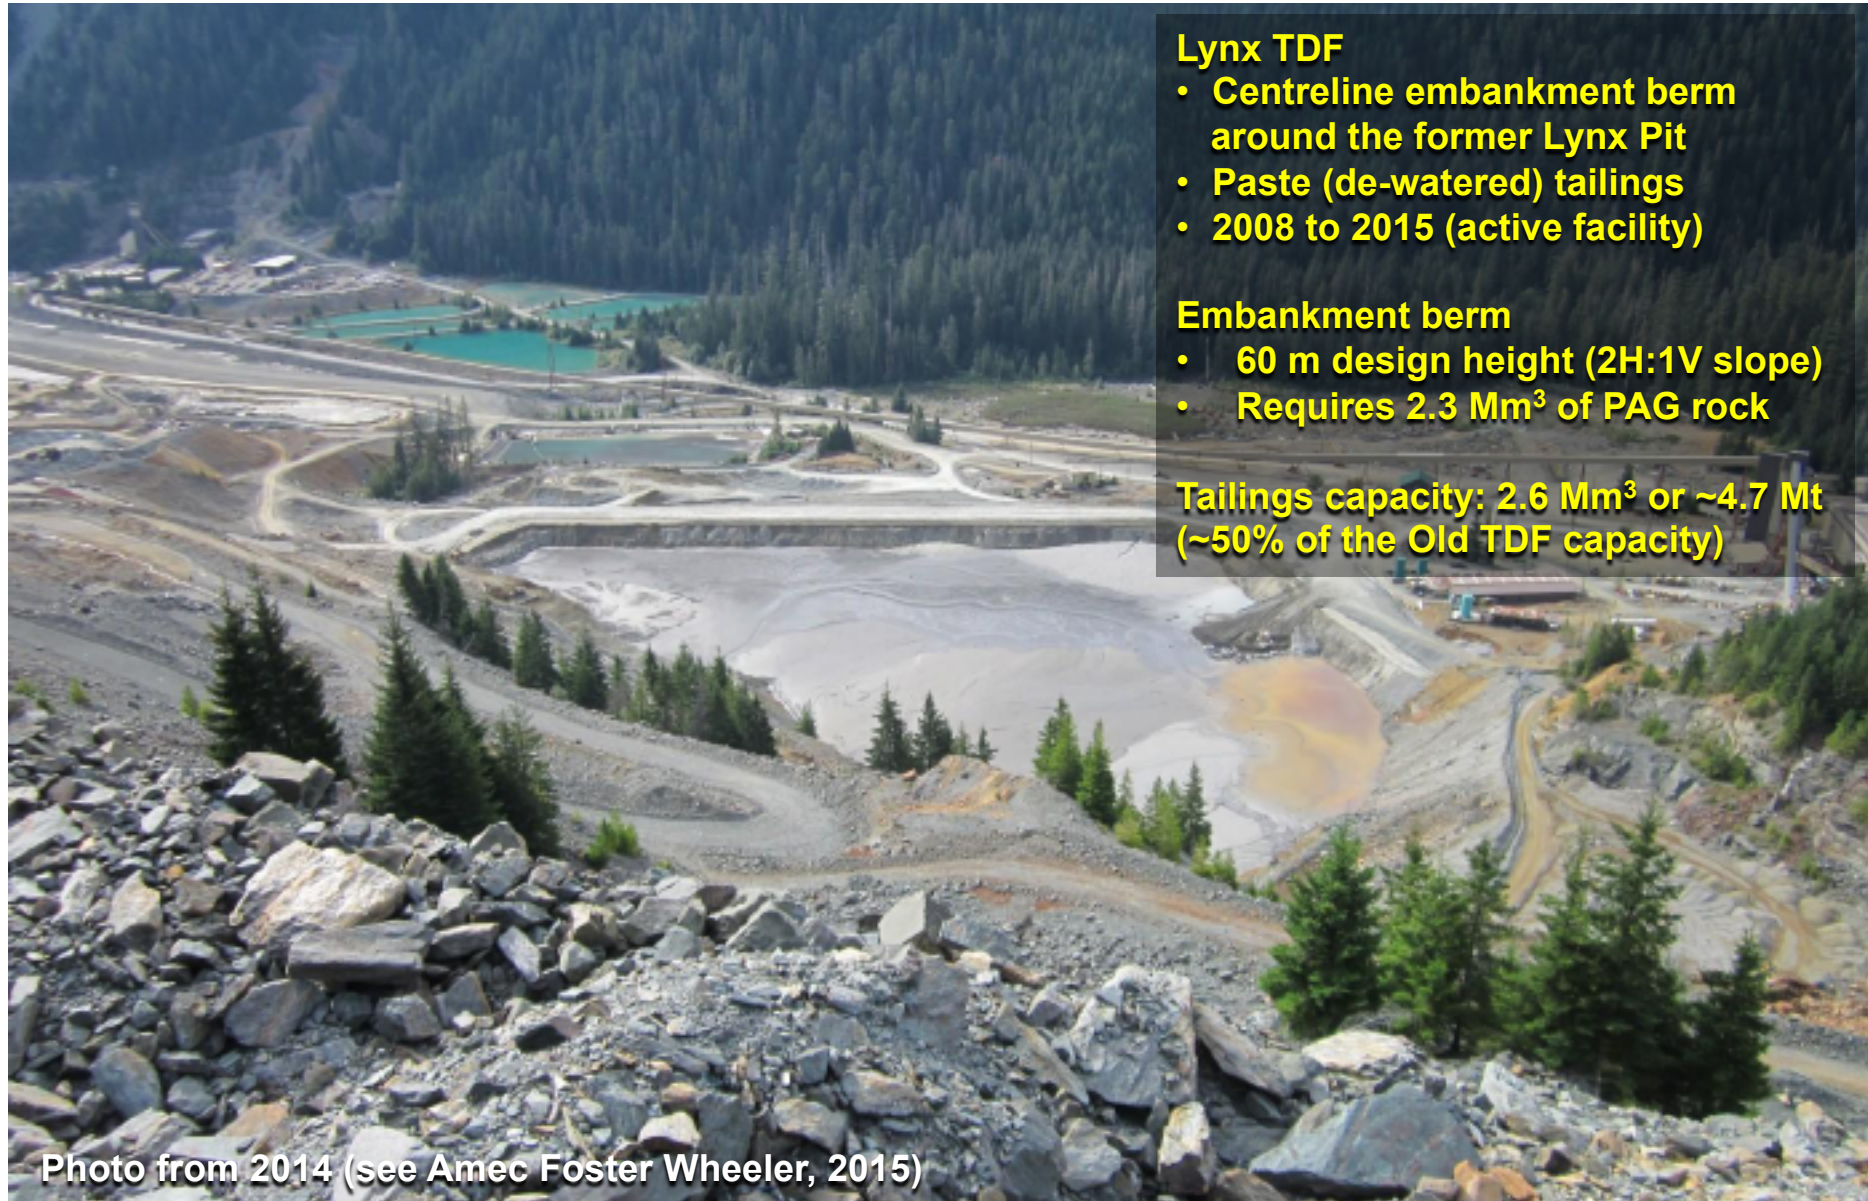
# Lynx TDF

## Lynx TDF

- Centreline embankment berm around the former Lynx Pit
- Paste (de-watered) tailings
- 2008 to 2015 (active facility)

## Embankment berm

- 60 m design height (2H:1V slope)
- Requires 2.3 Mm<sup>3</sup> of PAG rock

Tailings capacity: 2.6 Mm<sup>3</sup> or ~4.7 Mt  
(~50% of the Old TDF capacity)

Photo from 2014 (see Amec Foster Wheeler, 2015)

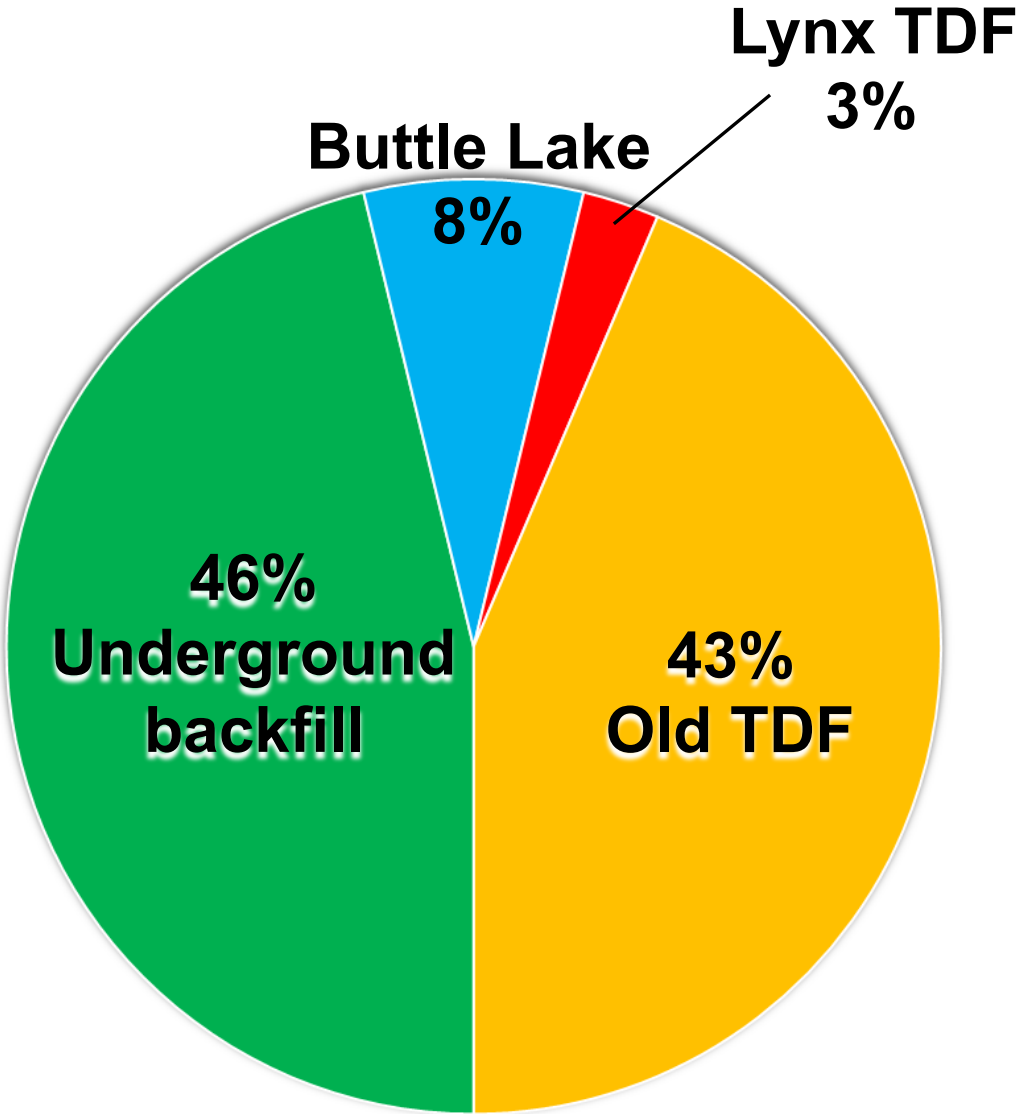
# Tailings Inventory

**30 Mt**

**(1966 to 2015)**

No production in 2016 or 2017

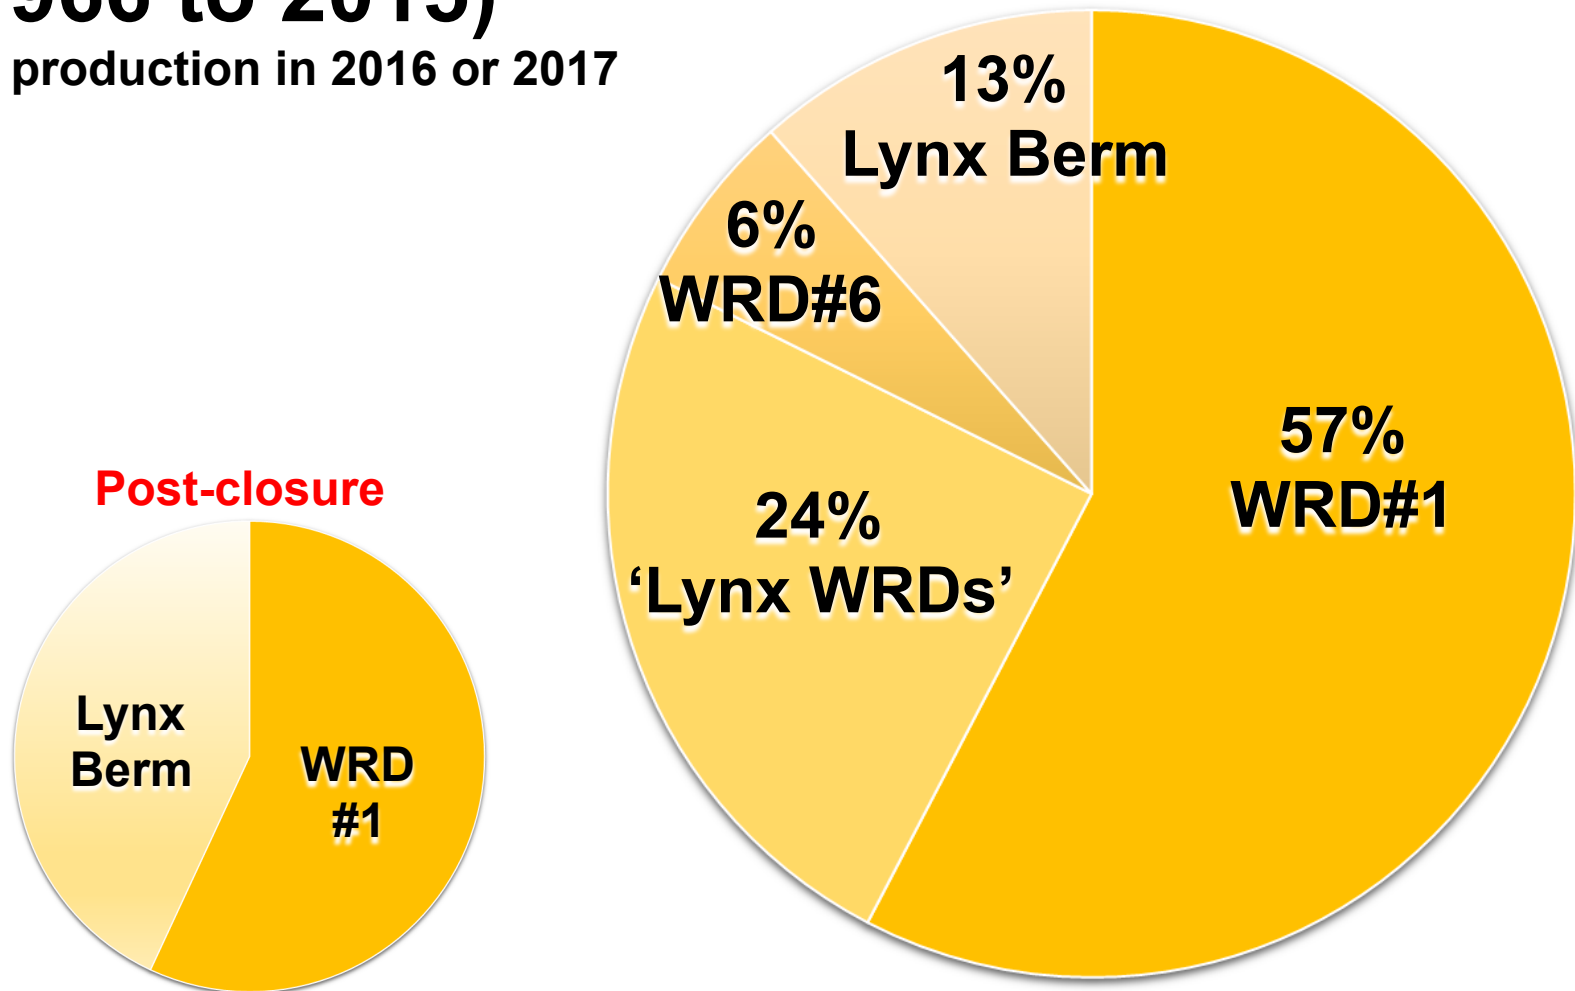
# Waste Rock Inventory (Surface)

12 Mt

(1966 to 2015)

No production in 2016 or 2017
