B.3. Bell Mine – Drainage Collection and Discharge

Bell Mine – Drainage Collection and Discharge

Bell 92 Project

BELL MINE
WATER MANAGEMENT MANUAL

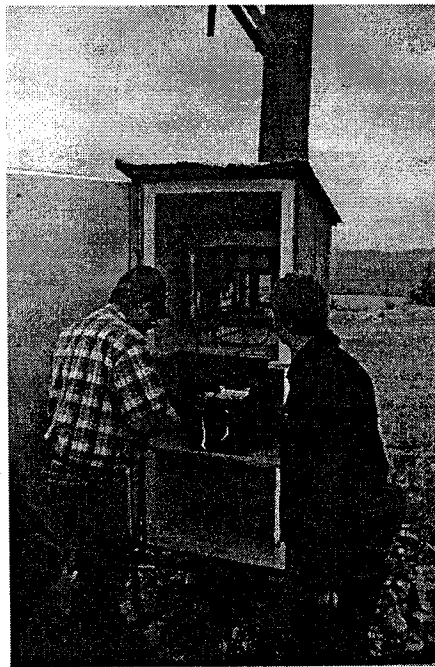
WIZCOM RADIO TELEMETRY MONITORING SYSTEM

The Wizcom system is a Supervisory Control and Data Acquisition (SCADA) system which gathers information from remote stations and transmits the data to a base station computer for on time reporting, analysis and storage. The radio telemetry equipment features packet switched store-and-forward data transmission technology with advanced error correction coding structures. The central site computer facility utilizes the QNX multi-tasking, multi-user, operating environment specifically developed for IBM compatible personal computers.

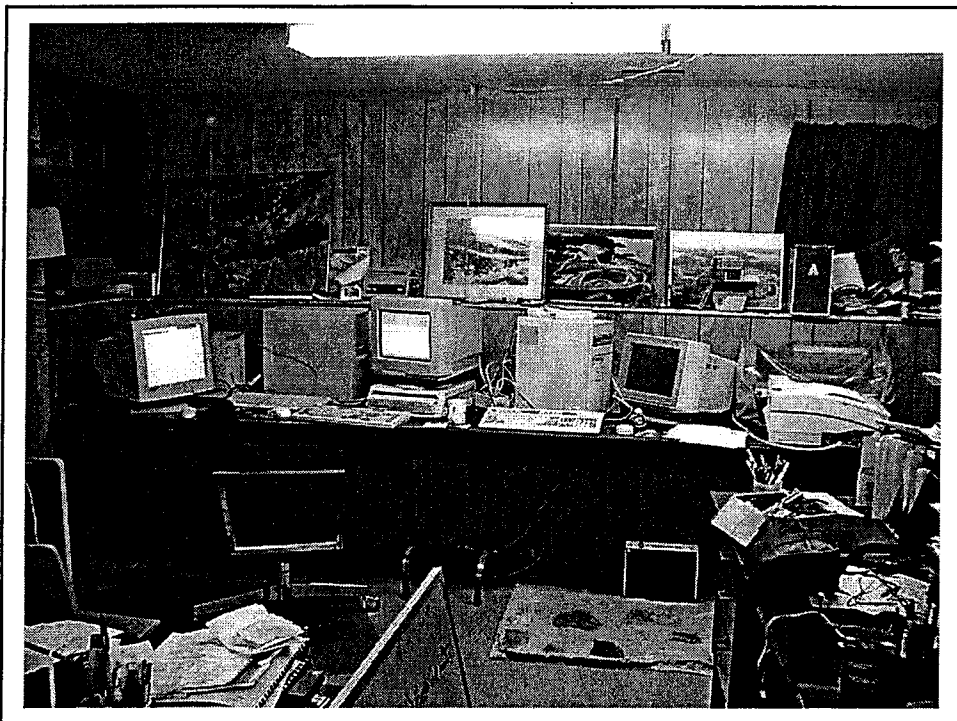
The Bell Mine Monitoring System consists of a Remote Terminal Unit (RTU) at each pump station. These communicate via radio telemetry to the Central Terminal Unit (CTU) at the Security Office. Each RTU has battery back-up power, terminal strip connection for analogue, digital and status devices, data logging memory, a radio telemetry port, and a serial port. The CTU receives information from RTUs and is connected to the base station 386 PC type computer that runs DataCommand software. In addition to data capture, control management, alarm analysis, and network communications, the base station computer provides password protected operator displays and accepts input for interrogations and control actions.

The following information is stored and/or gathered by the RTU at each pump house:

- Pump 1 Status (on, off, or FAIL)
- Pump 2 Status (on, off, or FAIL)
- Pump 1 Switches (hand or auto)
- Pump 2 Switches (hand or auto)
- Reservoir Controller (online or offline)
- Pump 1 Control (online or offline)
- Pump 2 Control (online or offline)
- Water Level (feet)
- Flow Meter (gallons per minute)
- Battery Power (volts)
- Power Status (on, off)
