# 10<sup>th</sup> Annual BC ML/ARD Conference

Elliot Lake – Status Report on Water Cover Performance Simon Fraser University, Vancouver, Dec 2-3, 2003 Ken Black, Art Coggan, and Maxine Wiber

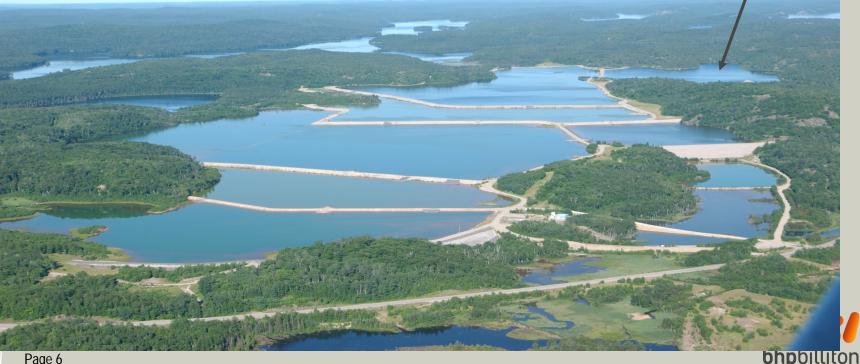
# **QUIRKE – History and Characteristics**

- Flooding completed in 1995
- Dykes have spillways designed to pass peak flows
- Eight low permeable dam structures along perimeter of facility are designed to contain tailings and reduce seepage
- Gravel Pit Lake supplies water to basin to maintain water cover -

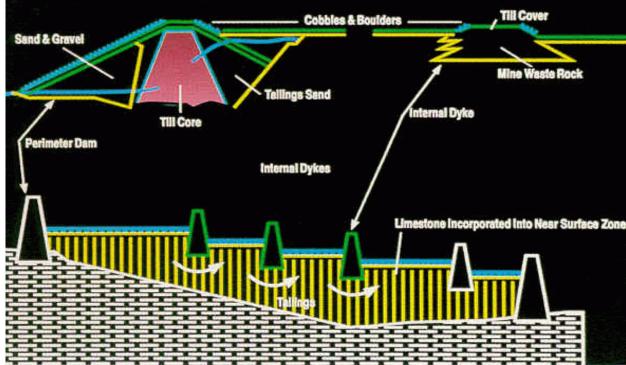
# **QUIRKE – History and Characteristics**

•Gravel Pit Lake supplies water to cell 14, thus flowing cell to cell, discharging from cell 18; observed radium concentrations approaches background (20 ppm) in Cell 14 • Operated 1956 – 1961, 1968 to 1990

tailings basin capacity is 192
ha

42 m tonnes acid generating tailings containing < 5% S</li>

5 tiered cells with 3 meter elevation between cells separated by waste rock dykes

Leakage between cells approximately 3 times design; contributor to the observed radium levels in water cover

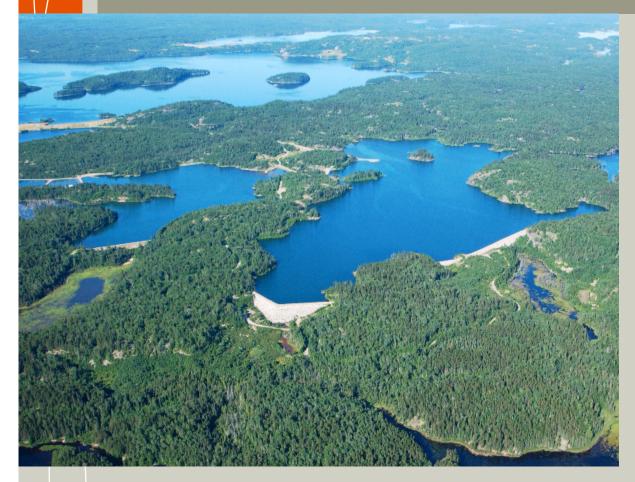
# **PANEL – History and Characteristics**

**Operated from 1958 to 1961, then 1979 to 1990**

•14 million tonnes of tailings in 123 ha. basin

• Situated natural rock with low permeability dams at perimeter low points

Acid generation essentially arrested following flooding to depth of 0.6 m

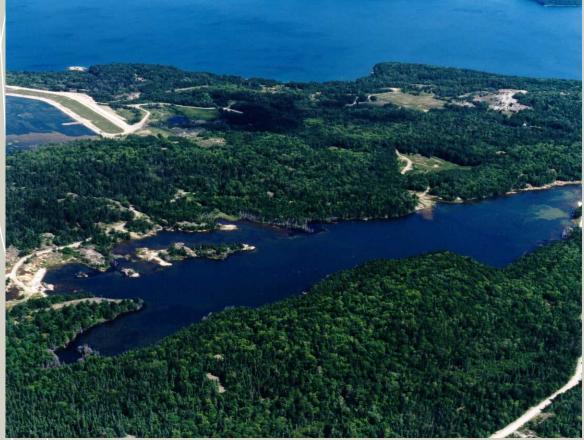
#### **SPANISH AMERICAN- History and Characteristics**

• Operated less than one year in the late 1950's; <0.5 m tonnes of tailings in Olive Lake

Permanent berm and spillway constructed to control water levels

- Drainage through a series of beaver ponds to Denison Tailings Management Area
- In- basin liming during cover formation.
- Minimum water cover of a 1.5m
- Radium levels at 0.6 Bq/L

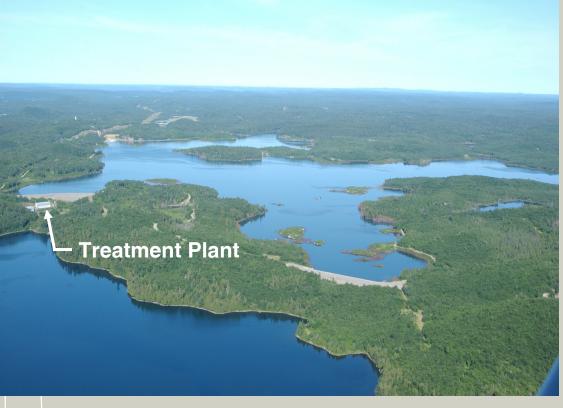
# **STANLEIGH – History and Characteristics**

- Operated in 50's, then 1983-1996
- Moved 50,000 tonnes of tailings below water elevation, completed 1.5 m thick water cover in 2002
- Dams and control spillway constructed
- In- basin liming during cover formation.
- Treatment systems reconditioned in late 2002
- •Radium levels 0.6 Bq/L, pH is 6.8
