Geomembrane Cover on Normétal Reactive Tailings: A Case Study

Toby Hofton SNC-Lavalin inc.

Rick Schwenger, Xstrata Zinc

CLOSURE CONCEPT

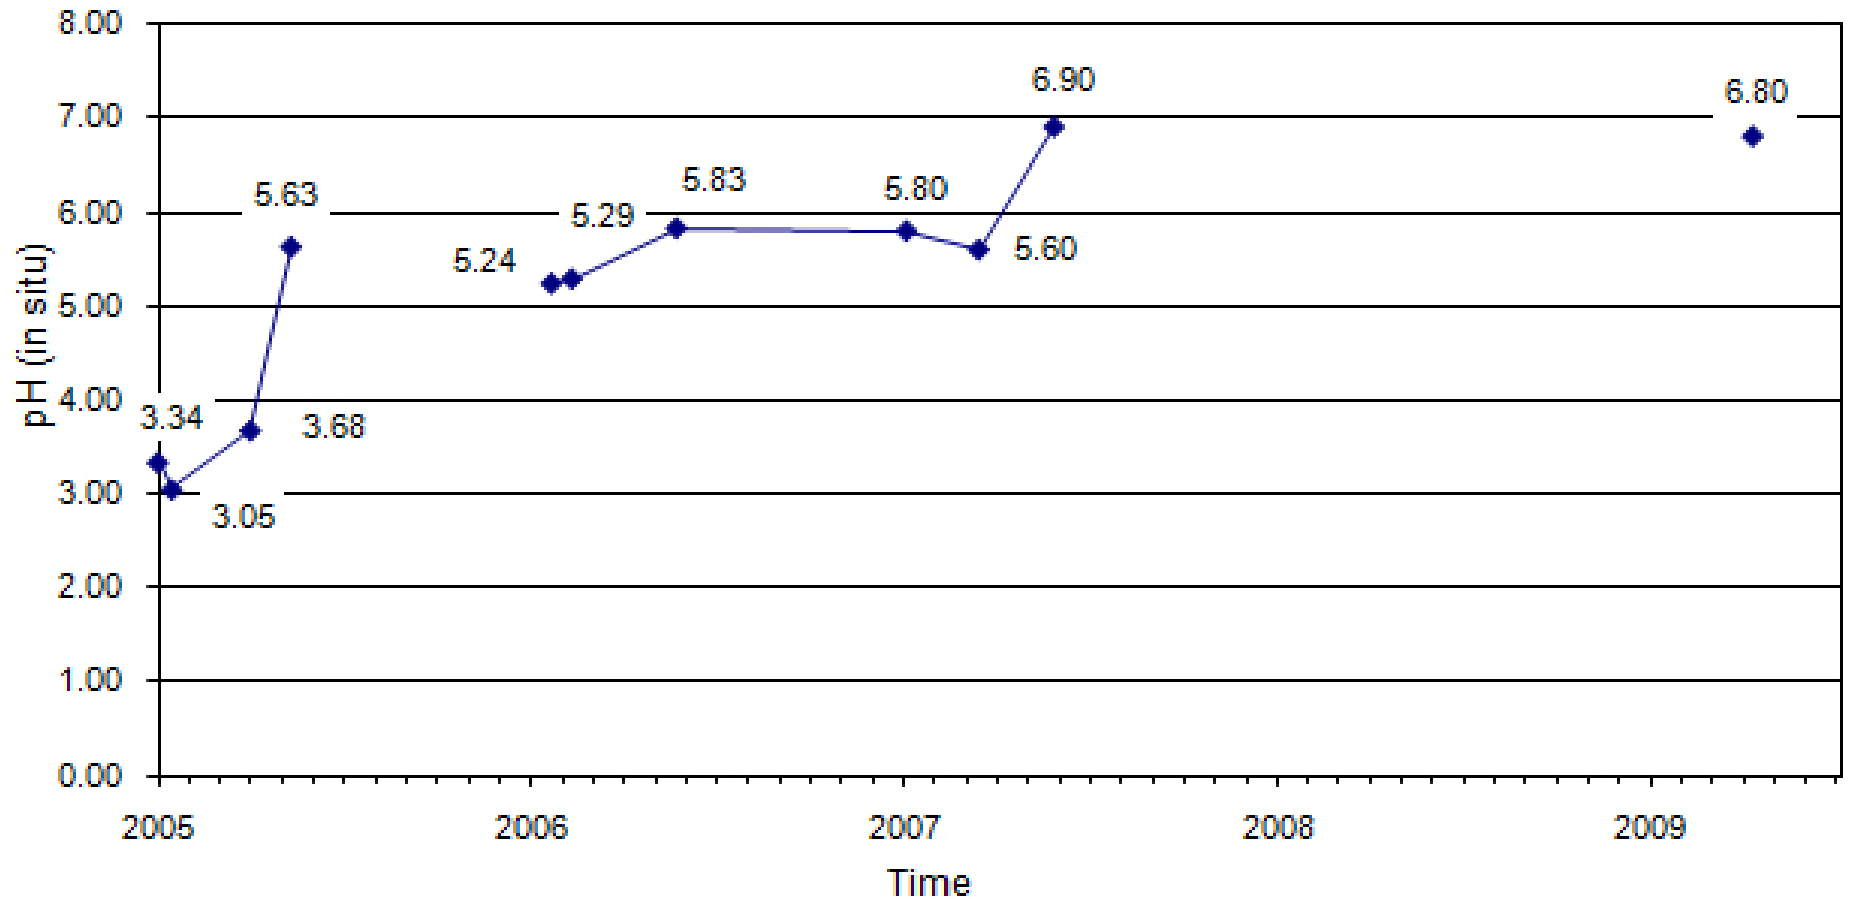
Des Méloizes River - Downstream from site Variation of pH with Time

- **Liner cover completed in September 2006.**
- Over time, drawdown of water level within impounded tailings of 5.8 cm/ month
- Reduction hydraulic gradient = reduction in flow rate of contaminated water: 150 L/ min to 103 L/ min between 2006 and 2008
- Improved downstream pH and iron and zinc concentrations

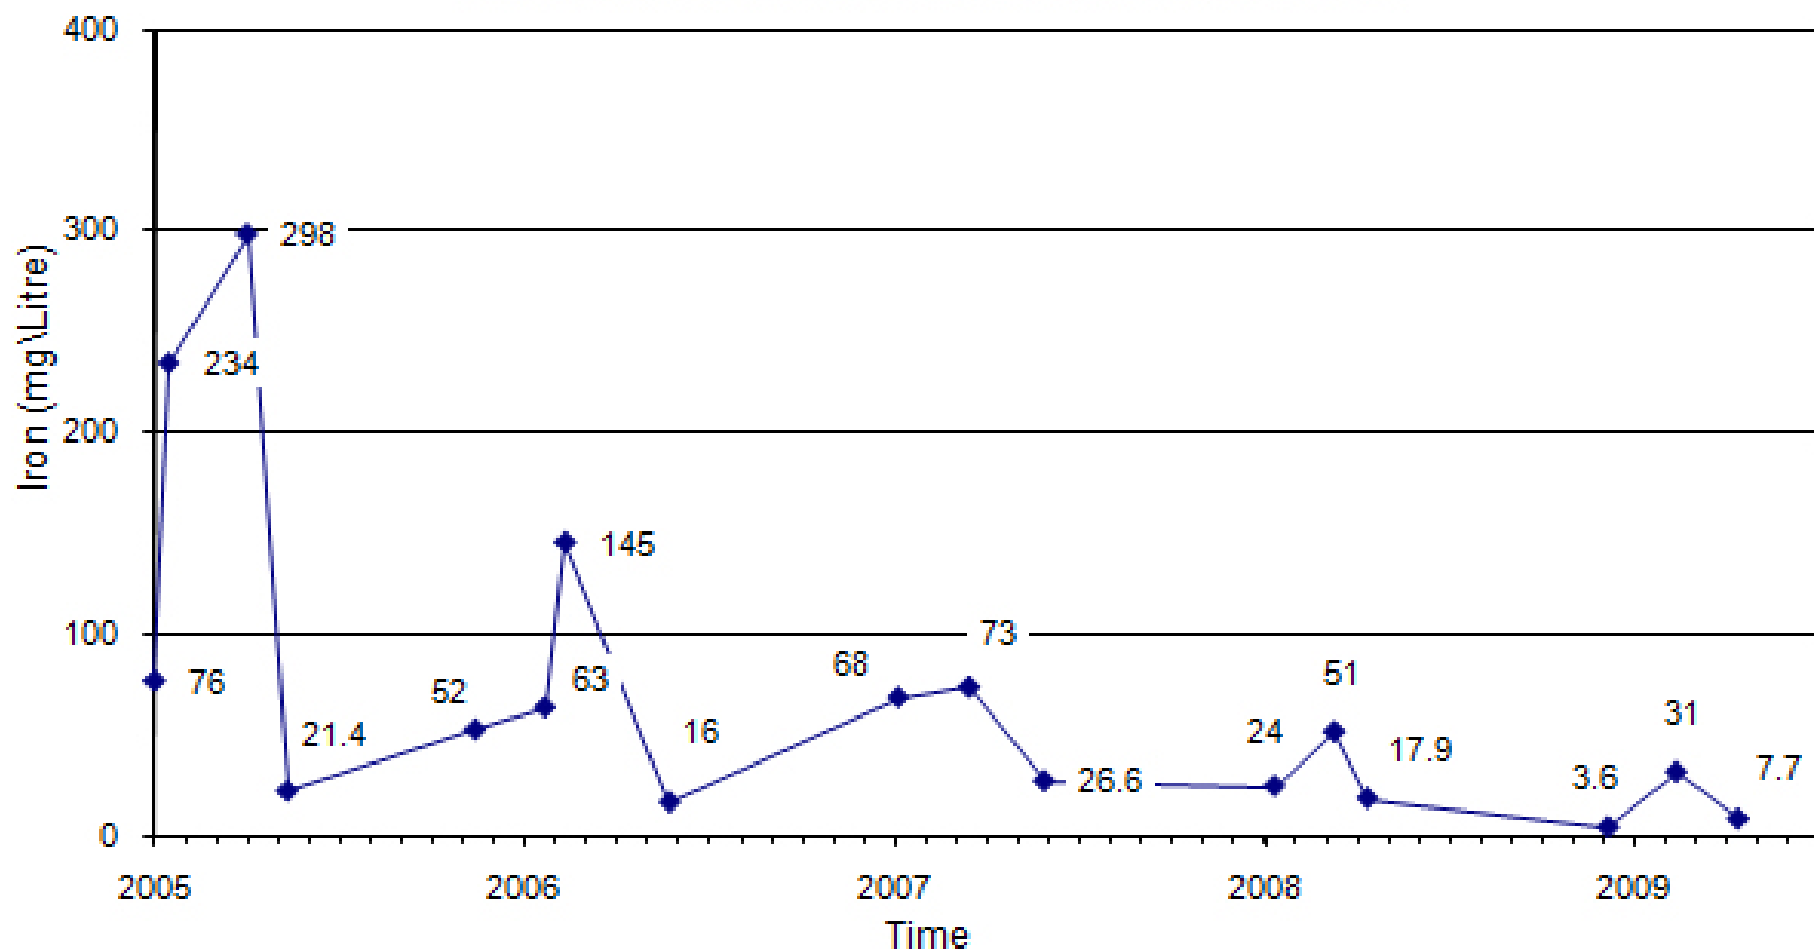
Des Méloizes River - Downstream from site Variation of Iron Concentration with Time

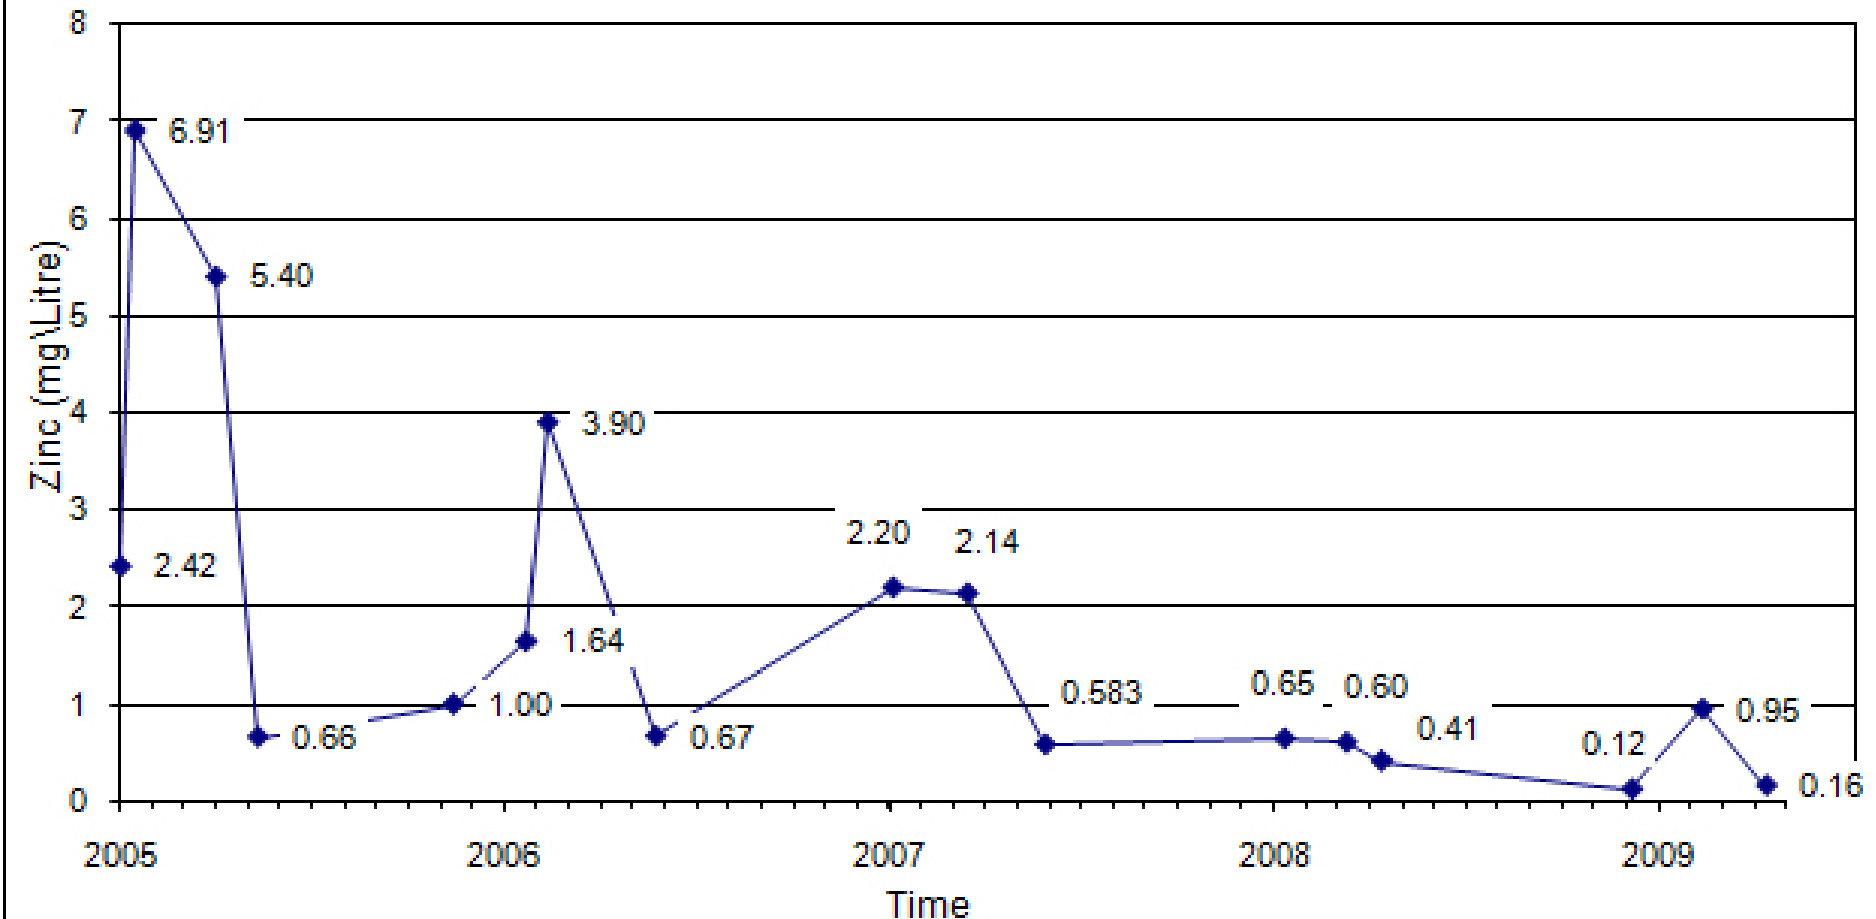
Des Méloizes River - Downstream from site Variation of Zinc Concentration with Time
