Case Study – Canadian Malartic

1. Introduction

Case Study Lessons Learned For Dewatered Tailings Projects

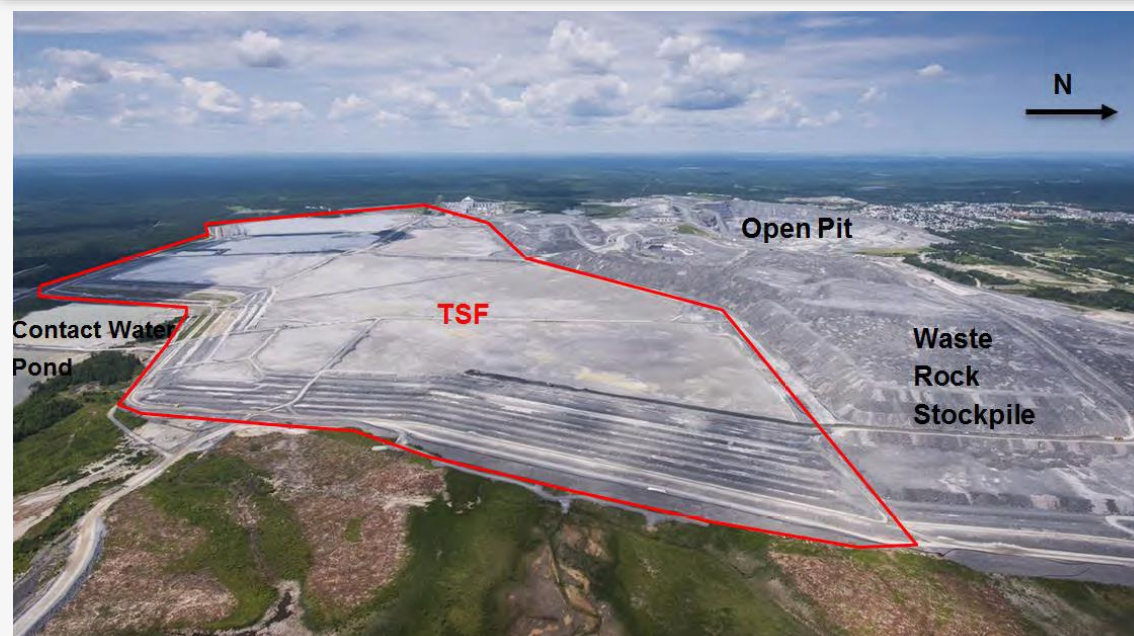
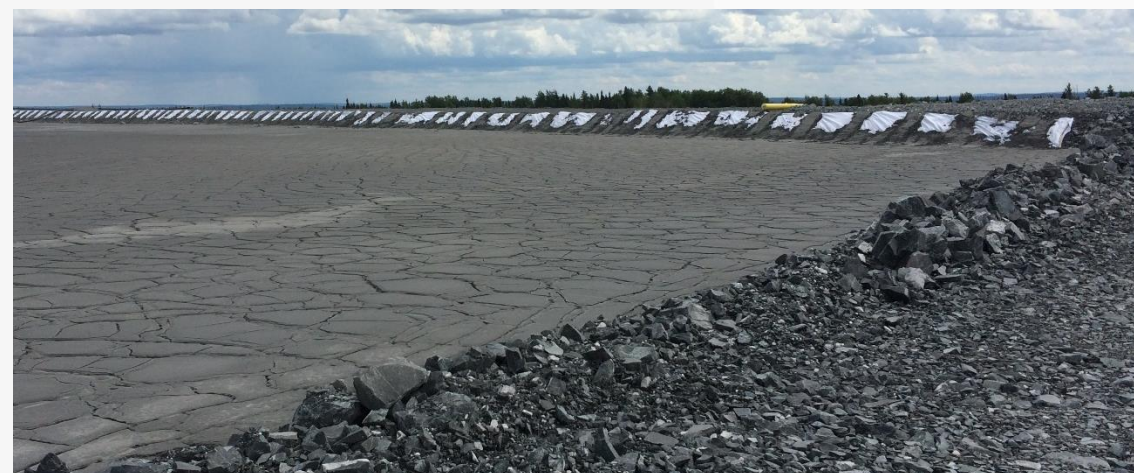
Image references: Doucet et al. 2015 (Top), Canadian Malartic (Bottom)

Tailings Facility Type: Conventional (with High Density Thickened Tailings) (64-65% solids)

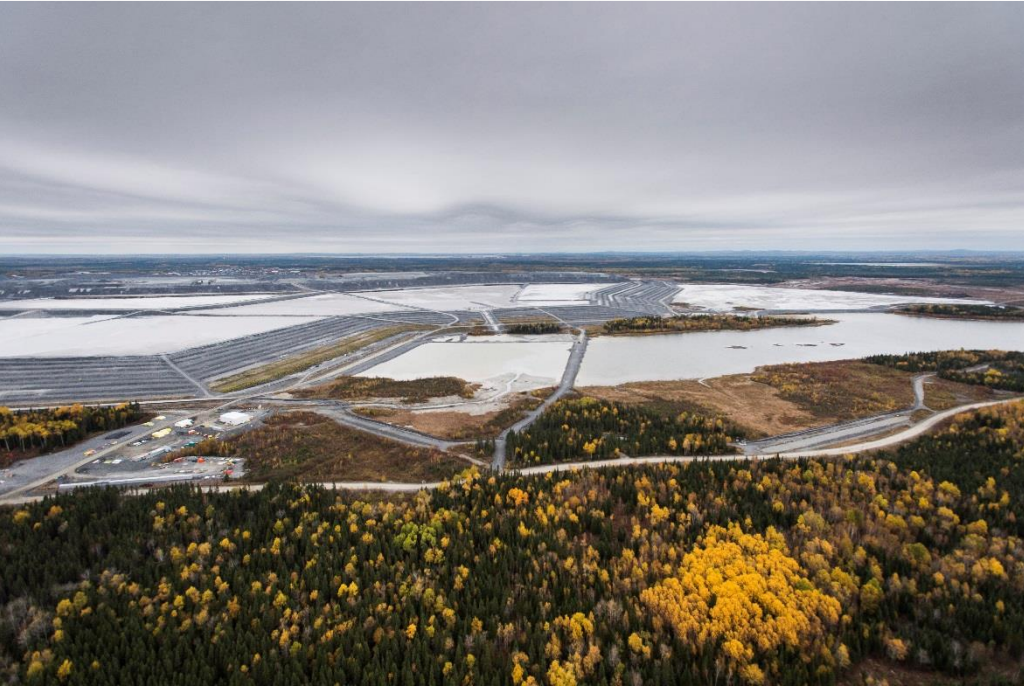
Canadian Malartic - Water Management

Image reference: Canadian Malartic

- The supernatant and runoff water reports to the reclaim water pond located south-east of the facility.
- The internal overflow spillways are situated near the centre of the South Perimeter and the Central Perimeter dykes.
- The supernatant and runoff water is 100% recycled to the process plant.

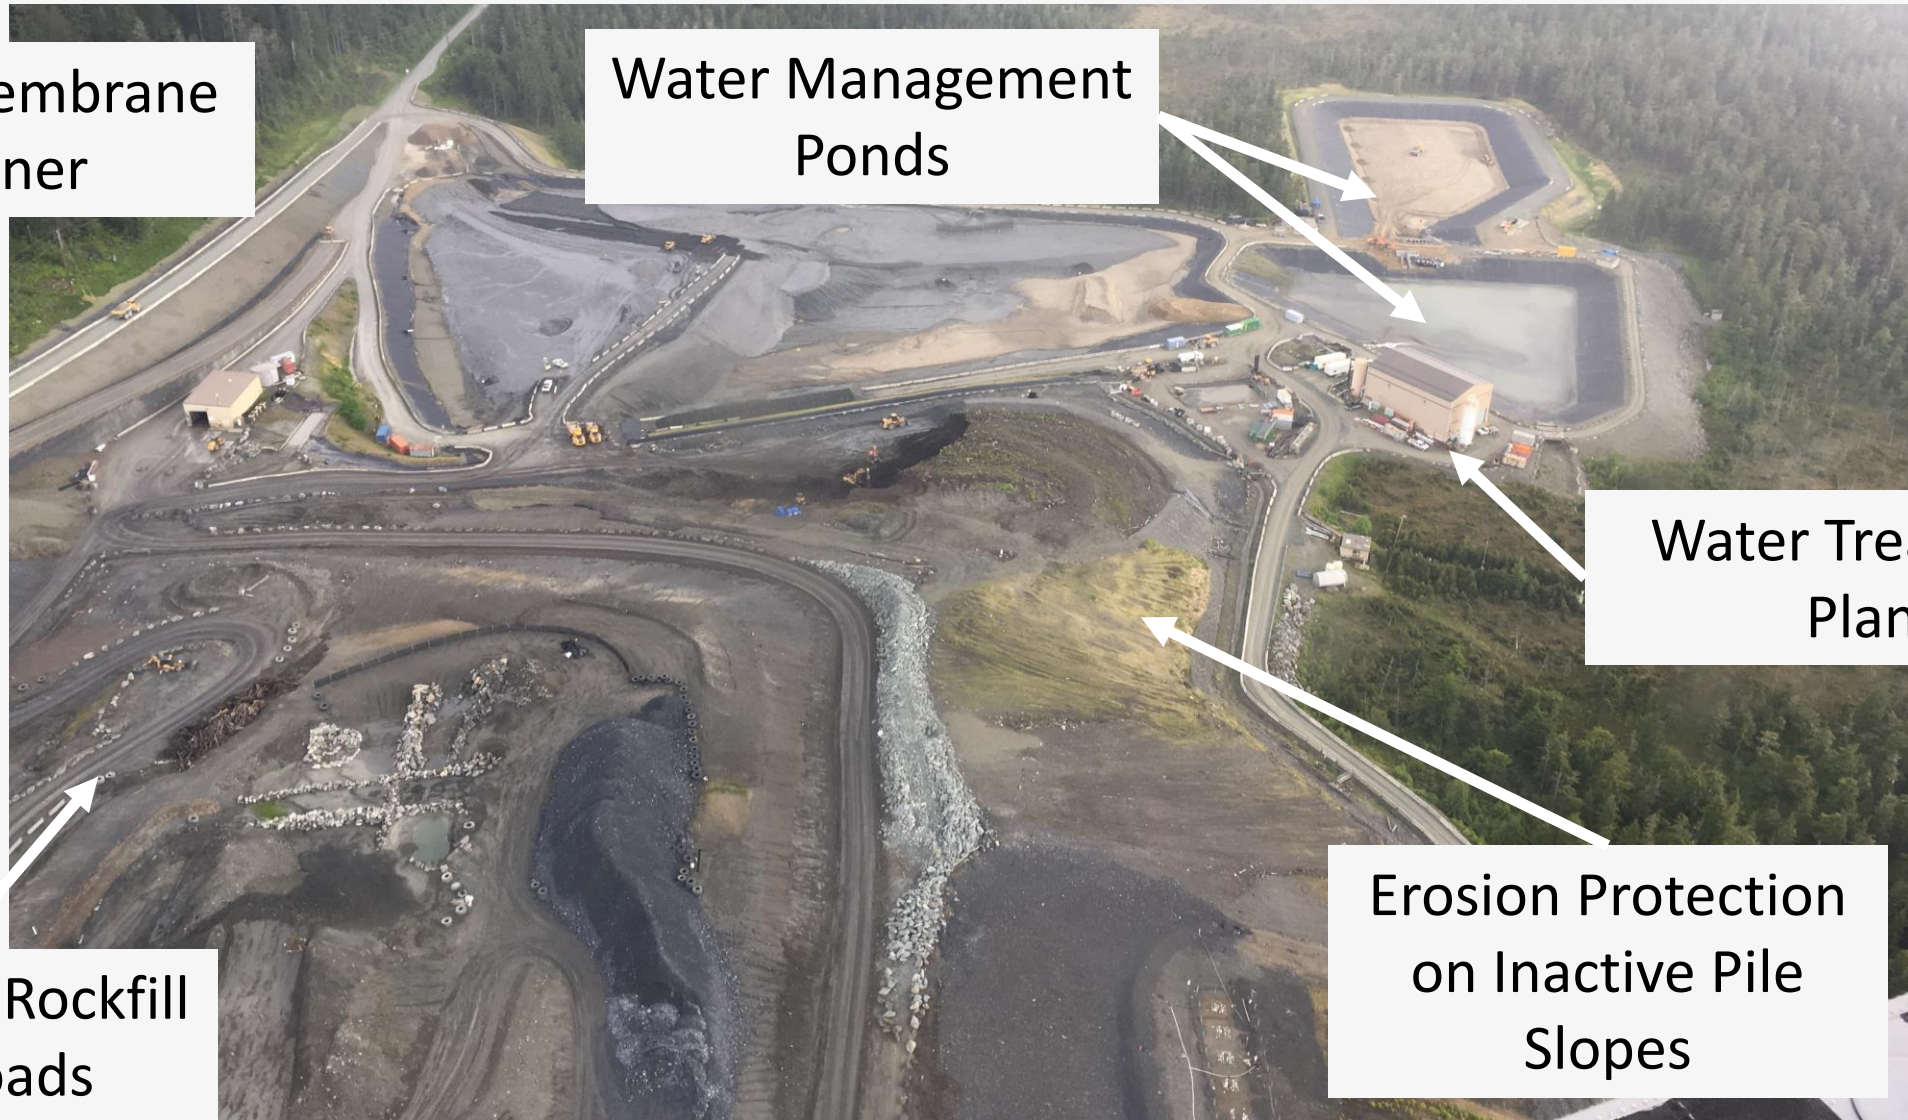
Greens Creek - Tour of the Facility

Geomembrane
Liner

Water Management
Ponds

Water Treatment
Plant

Erosion Protection
on Inactive Pile
Slopes

Temporary Rockfill
Haul Roads

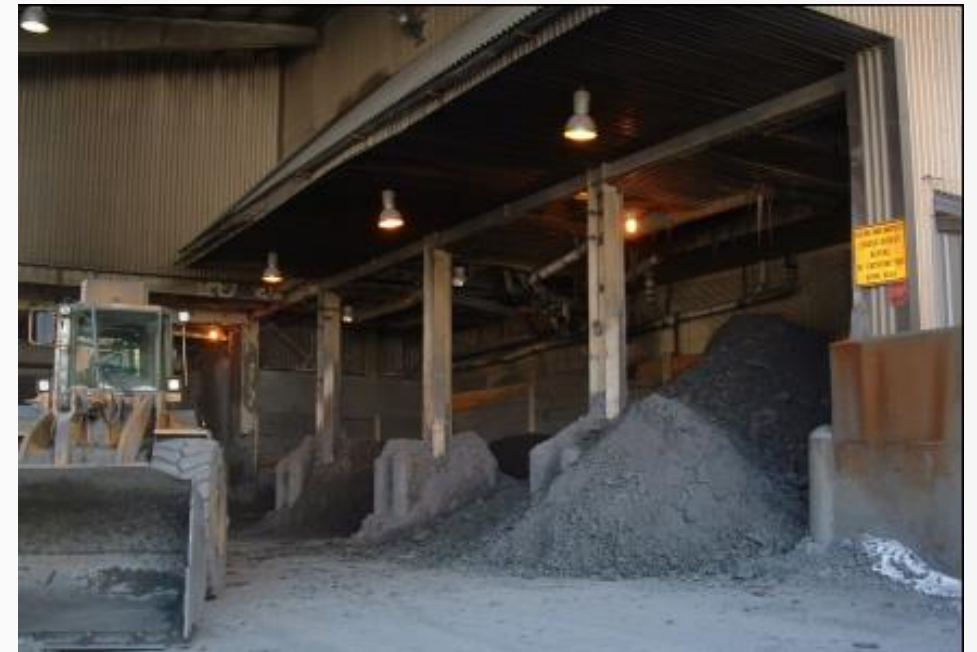
Filtered tailings was adopted to minimize overall footprint and for site-specific environmental and geotechnical considerations.

Because there is no pond on the tailings surface, there is little potential for tailings to be mobilized and transported significant distances if the pile were to fail during a seismic event.

Image reference: Condon 2012
