Current geochemical understanding and implications for long-term care of the closed Pine Point, NWT tailings impoundment area

Stephanie Theriault, Dale Kolstad, Todd Fasking (Barr Engineering and Science, Ltd.), and Michelle Unger (Teck Metals Ltd.)

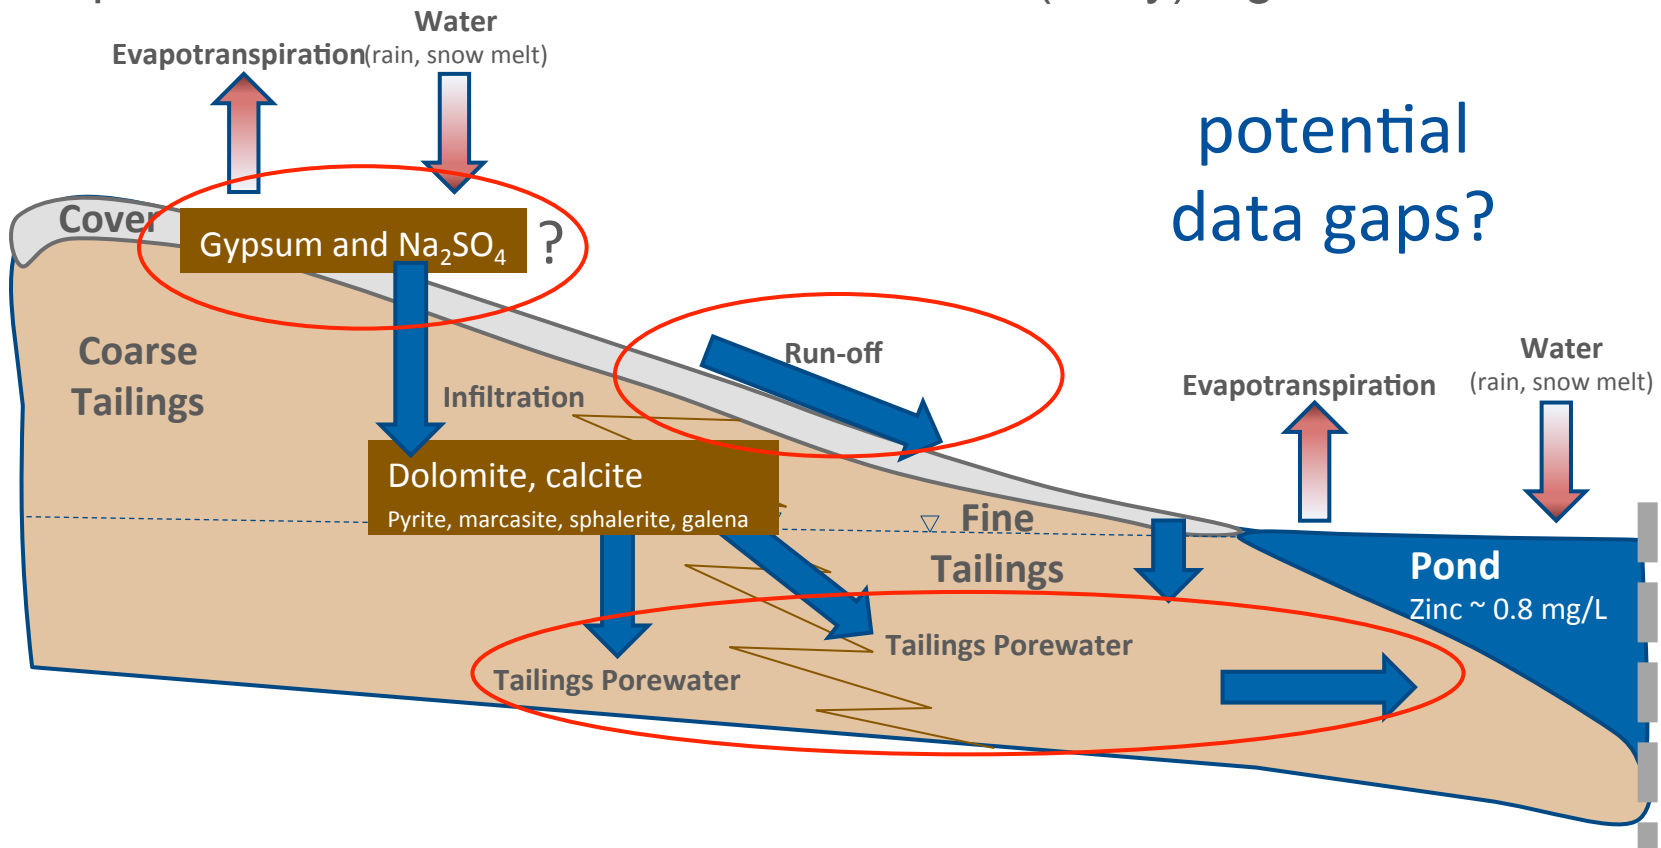
conceptual site model + preliminary water balance

- net evaporative
- pond inflow dominated by runoff
- porewater contributes lower volumes of (likely) higher conc water
