BC MEND ML/ARD ANNUAL WORKSHOP

## MEND Presentation - Kemess South TSF – ML/ARD Management

November 26, 2024

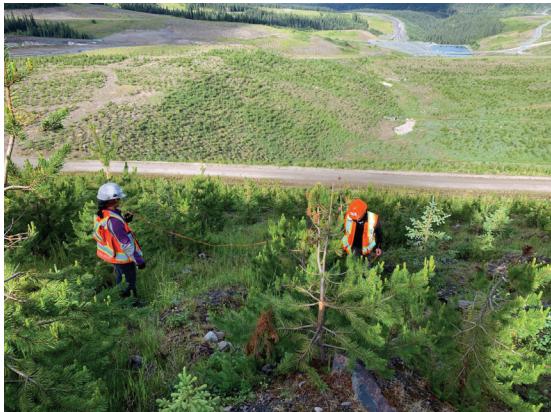
**Kemess South TSF embankment looking South**

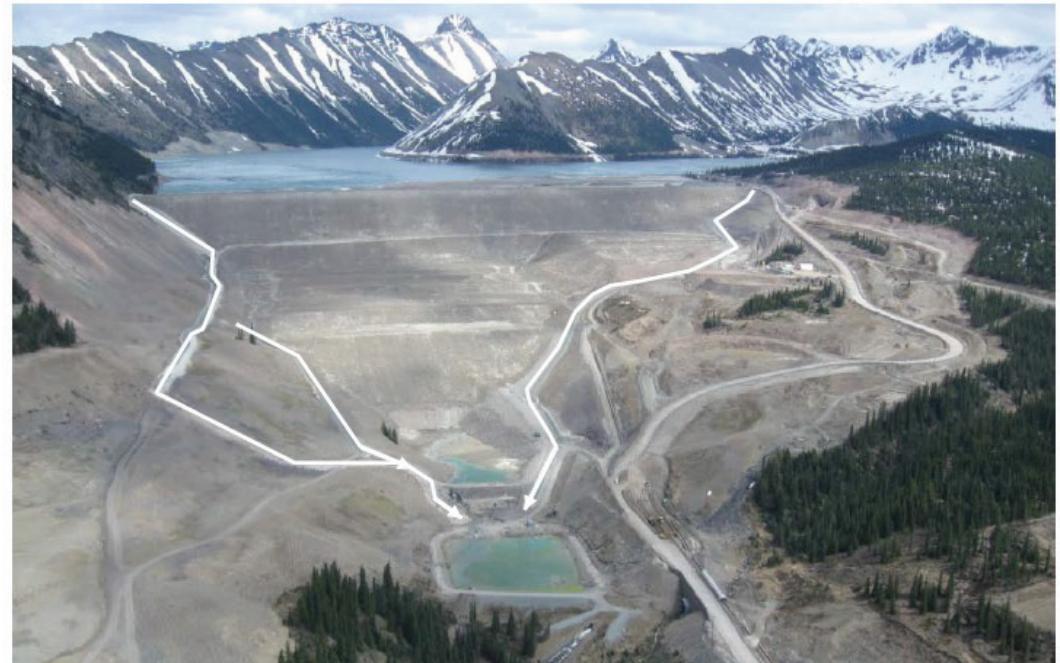
Figure 3.8: Runoff Diversion Ditches (white arrows). Photo taken May 2010.

- During mining operations, all seepage and supernatant water was collected, recycled, and had zero surface discharge, continuing into early C&M until water quality met authorized limits, enabling passive discharge.
- The 20-month transition period used recycling and freshwater input to reduce concentrations, after which the seepage pond (SP) was connected to the sediment retention pond (SRP) for controlled discharge.
- TSF dam safety fully complies with CDA guidelines, with regular inspections by the engineer-of-record (EOR), reviews by the independent technical review board (ITRB), and oversight by qualified personnel (QP) and resident tailings personnel (RTP).
- A monitoring program tracks dam performance, with ongoing reclamation and revegetation efforts to reduce surface erosion and minimize total suspended solids (TSS).

From 2010 KS RCP.

A diversion system around the south and east portion of the TSF to limit run-on into the TSF during the operation to reduce contact water. This diversion system also maintains a fresh water supply during the low flow periods for support of downstream fisheries resources in Kemess Creek during operation.
