Cluff Lake Project Decommissioning Process and Lessons Learned

Kebbi Hughes and Tina Searcy December 2023

Decommissioned Cluff Lake Project

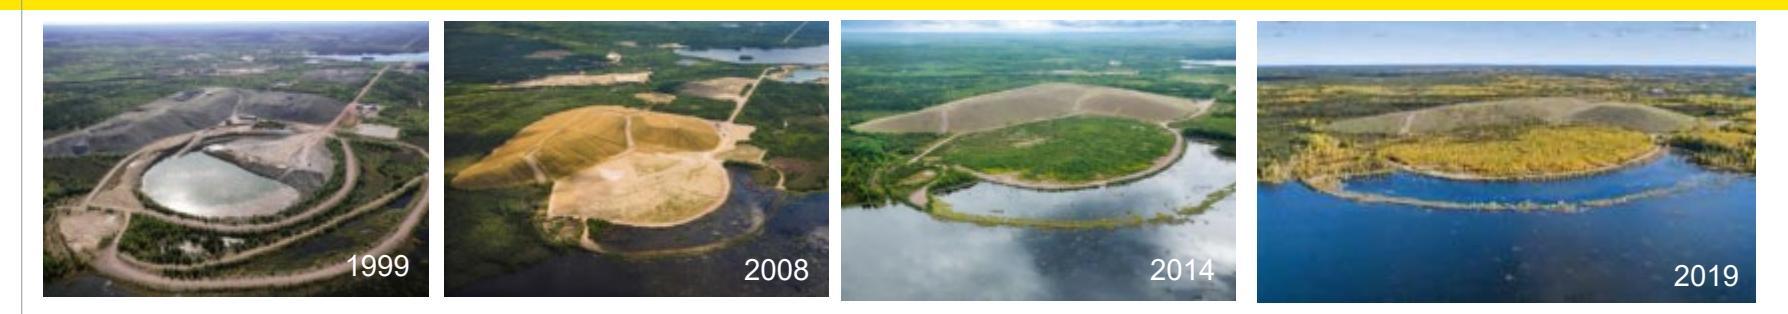
Claude Mining Area

- Pit was backfilled with waste rock and demolition debris, covered, planted with trees
- Waste rock pile was shaped, compacted, covered with a 'moisture store-and-release' till layer, and seeded
- Vegetation is self-sustaining, pile is stable, and successfully minimizing net percolation rates
- Achieving surface water quality in Claude Lake now and in the long-term

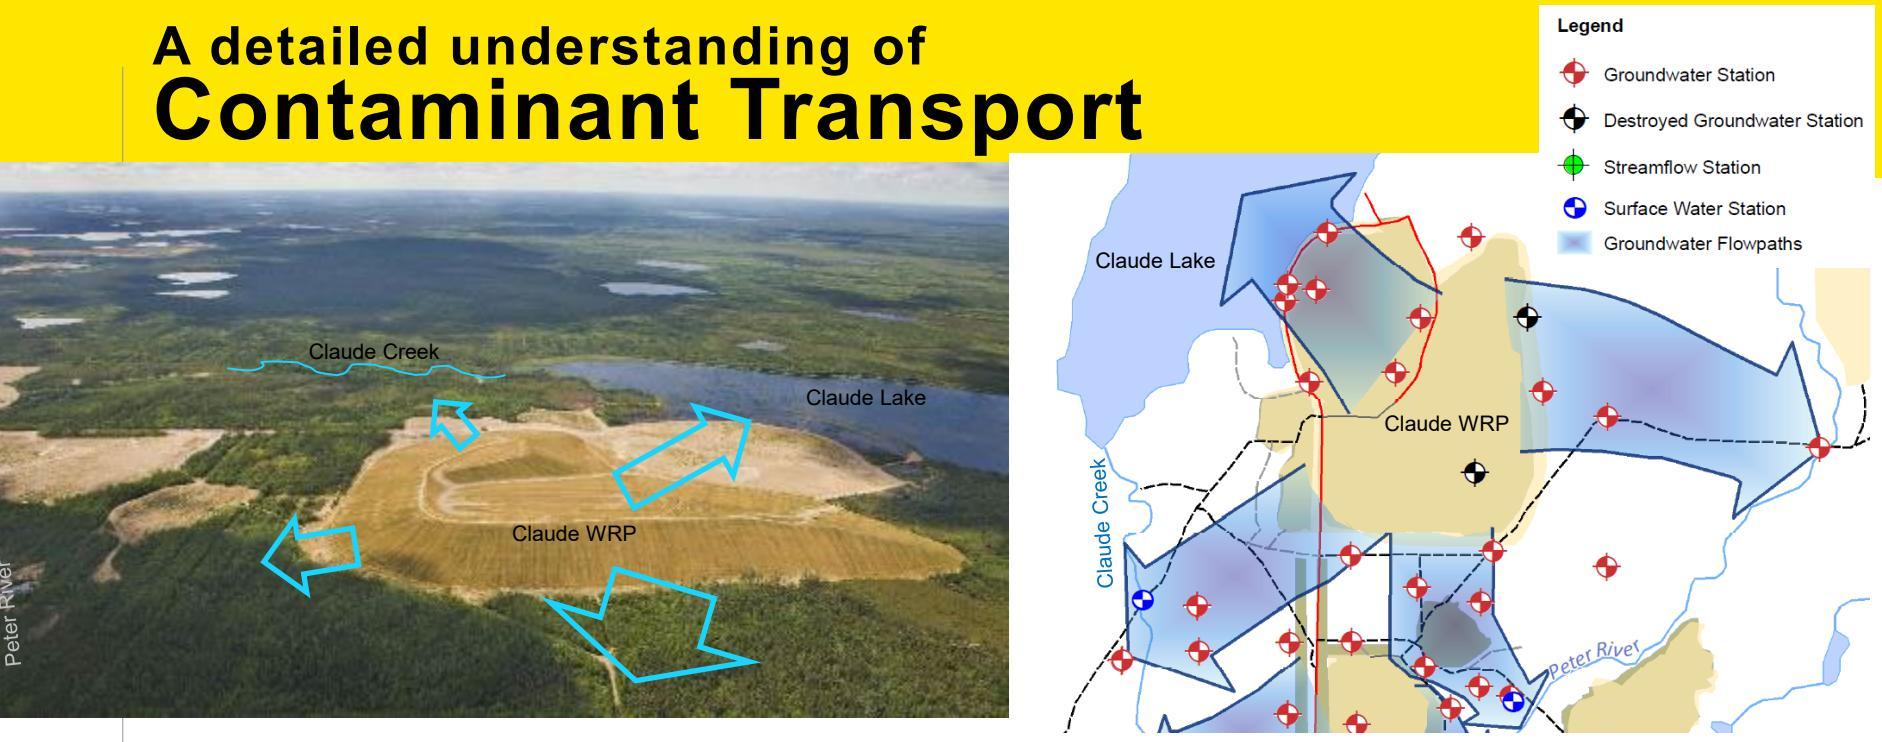
- Contaminant transport was modelled every 5 years incorporating new data
- The results feed into environmental risk assessments
- Understanding change over time gave a good understanding of site stability and key areas of risk

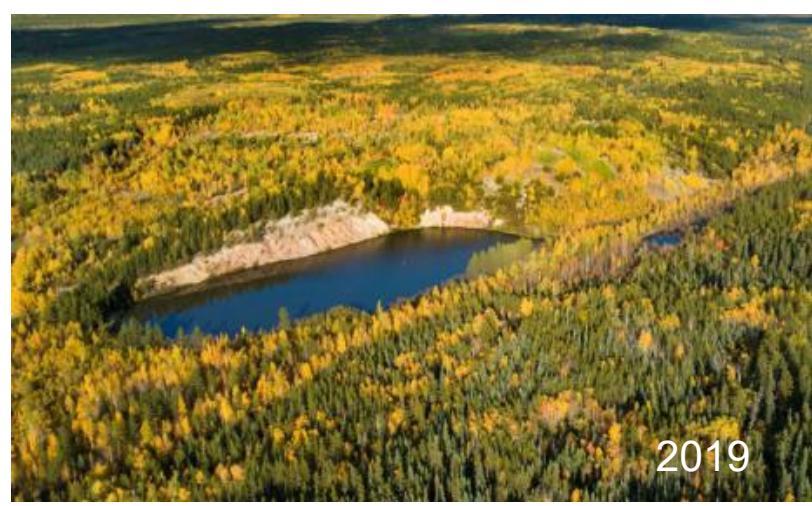
D Mining Area

- First deposit mined
- Decommissioned as pit lake, flooded in 1983
- Stable chemocline, surface water quality objectives achieved in the long-term

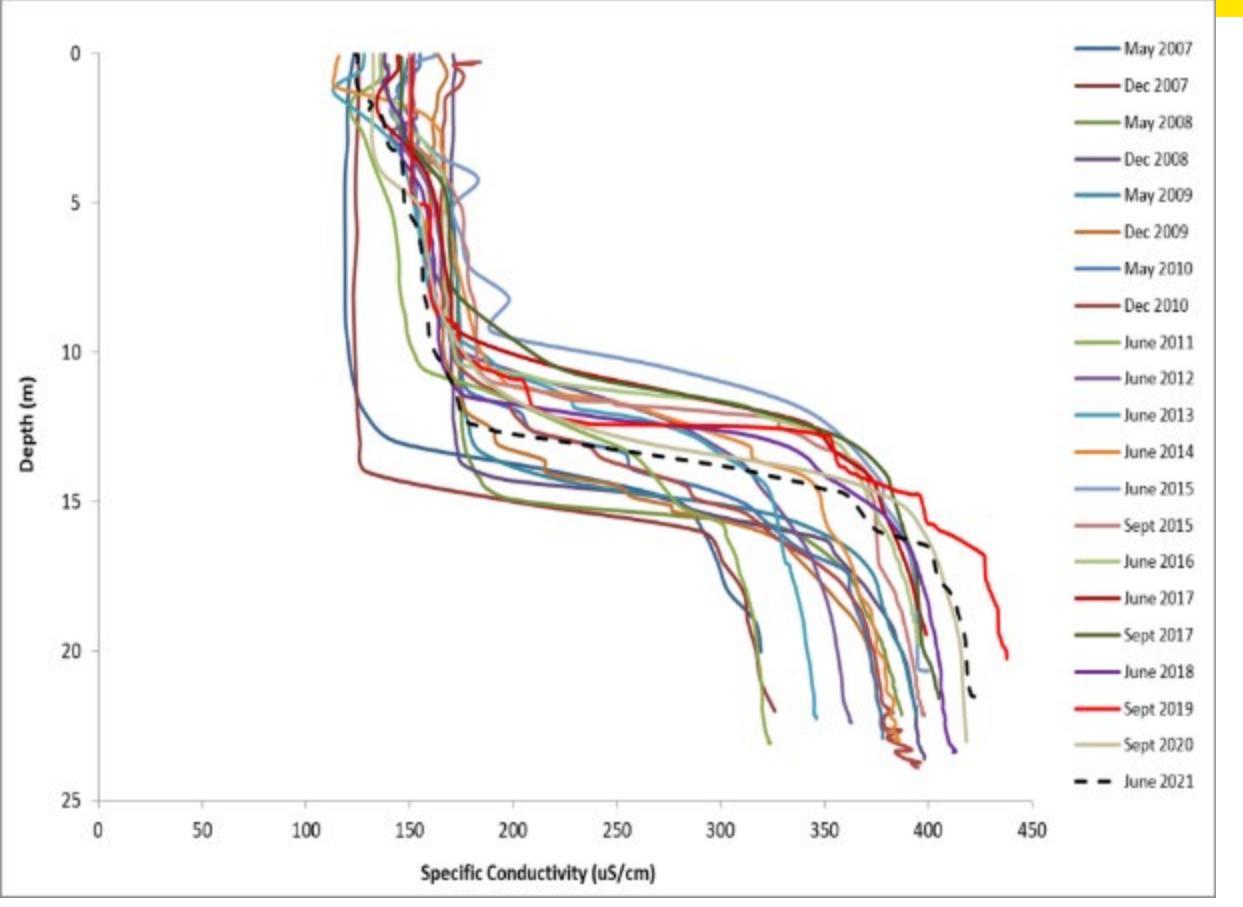
Establishment of Stable Chemoclines

D-Pit limnological profiles demonstrate a stable chemocline over 14 years

Water with higher concentrations of contaminants is sequestered at the bottom of the pit, never interacting with the surface water

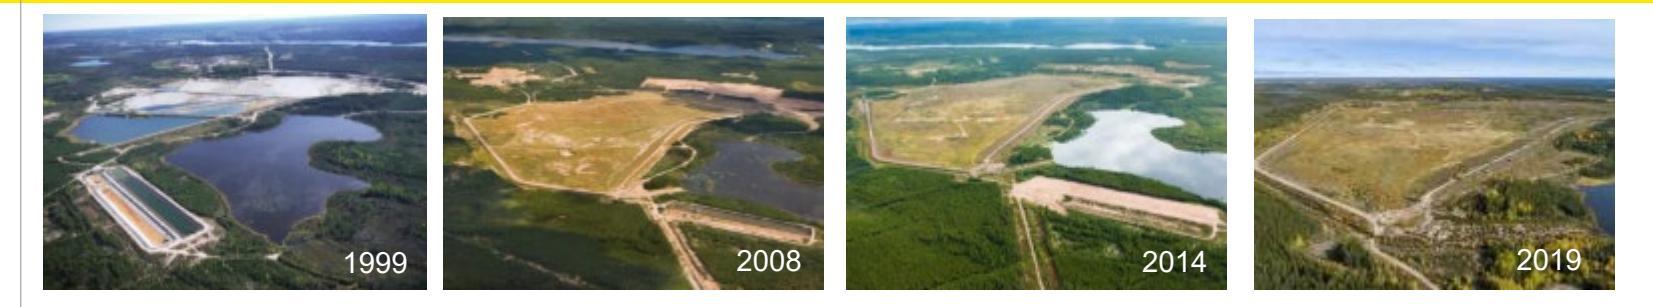
Tailings Management Area (TMA)

- Low permeability tailings consolidated to remove pore water
- Till 'moisture store-and-release' cover placed, graded, and seeded
- Vegetation is self-sustaining, storm water management achieved under passive care, design successfully minimizing net percolation rates
- Achieving surface water quality in Snake Lake now and in the long-term
