ML/ARD Workshop

Authors: Ben Chambers, Sharlene
Henderson and Ivor McWilliams

A HISTORY OF TAILINGS MANAGEMENT AT MYRA FALLS OPERATIONS

nvi MINING LTD.
MYRA FALLS OPERATIONS

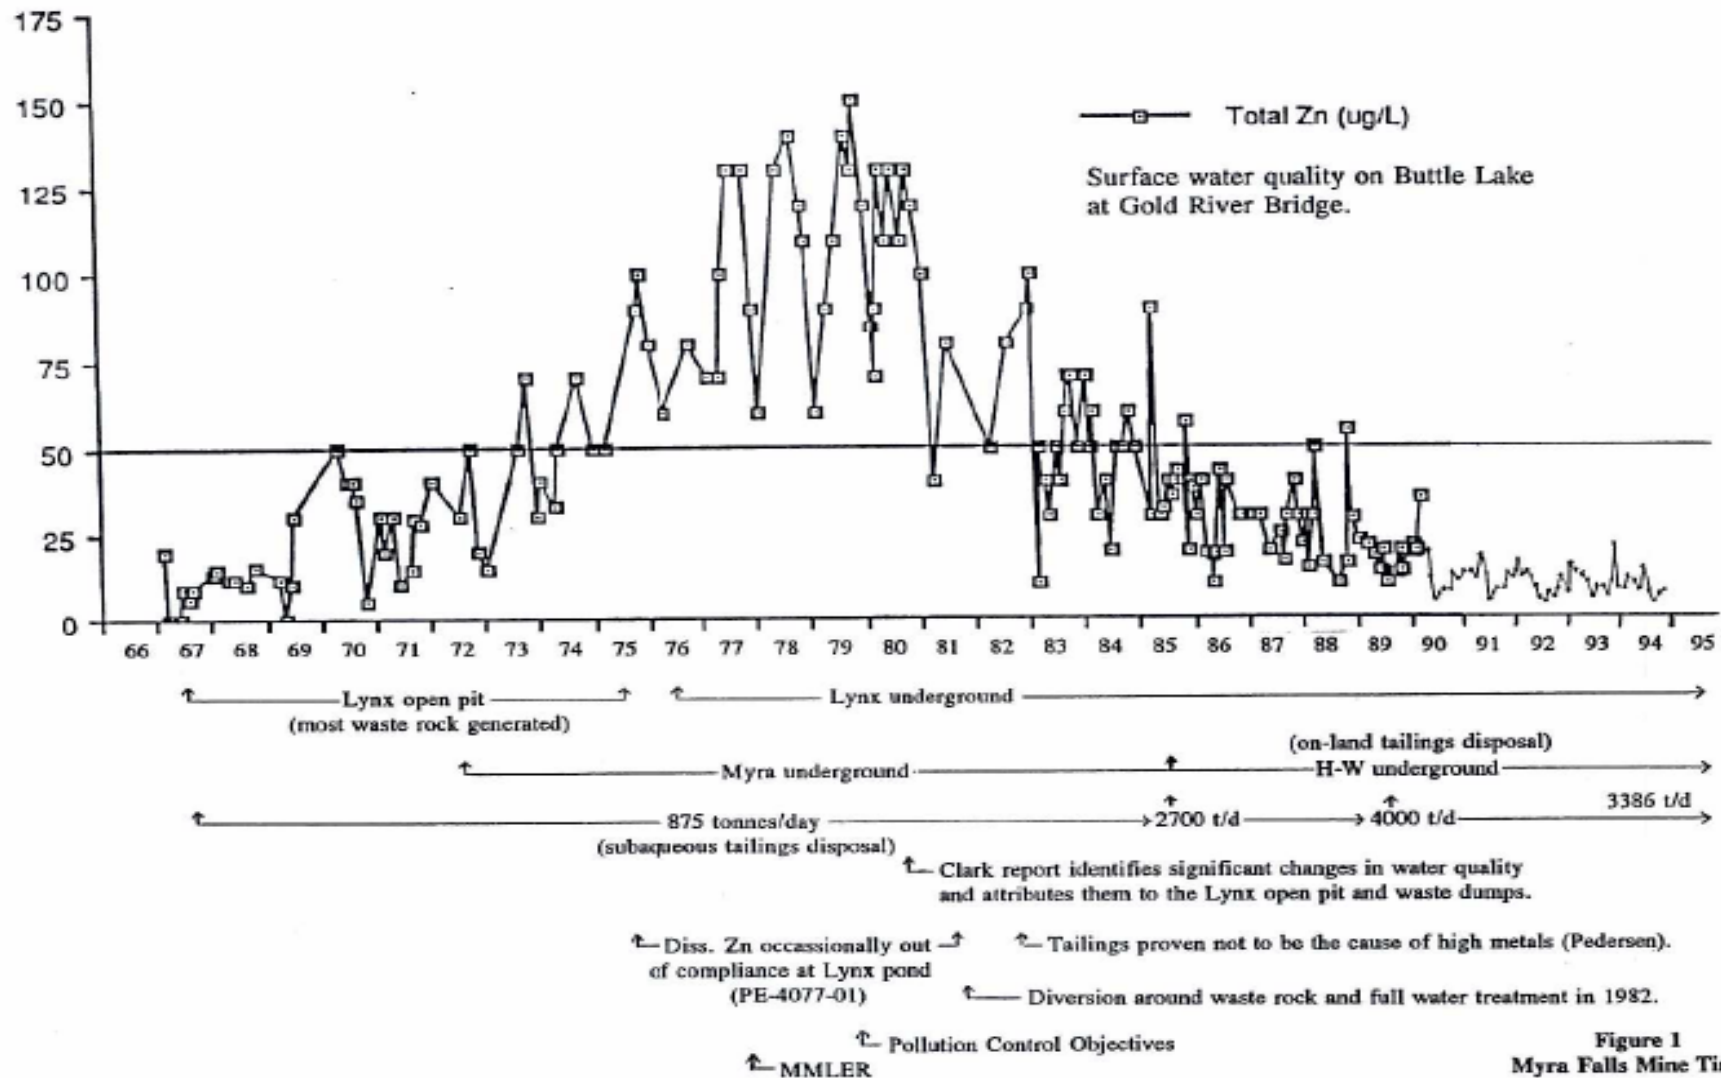
Figure 1
Myra Falls Mine Timeline

ZINC CONCENTRATIONS IN BUTTLE LAKE 1966-1995

- Tailings deposited in Buttle Lake between 1967 and 1984
- 2 million tonnes of tailings deposited into Buttle Lake over 16 years
- Deposition switched to a land based facility in 1984 as a permit condition following expansion and the discovery of the H-W ore body
- Community concerns contributed to the decision to change deposition strategies

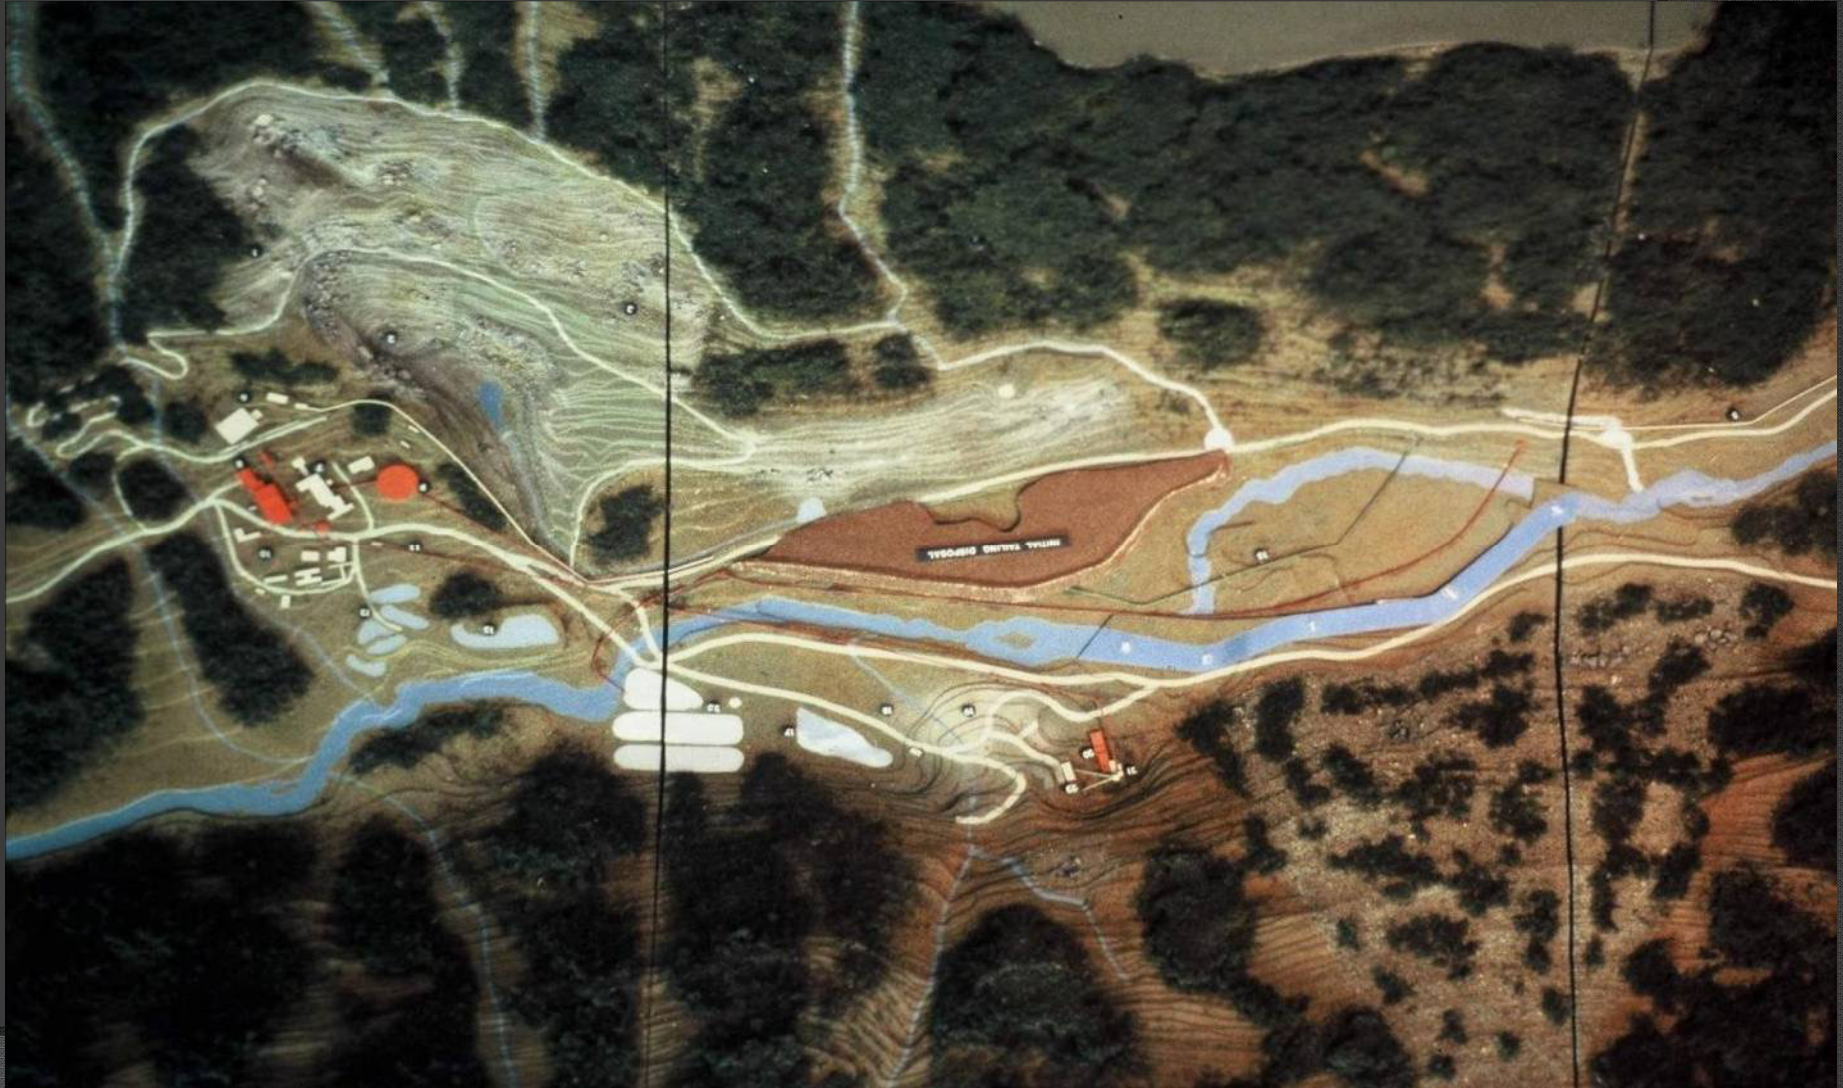
MODEL OF MYRA VALLEY PRIOR TO LAND BASED TAILINGS DEPOSITION - 1982

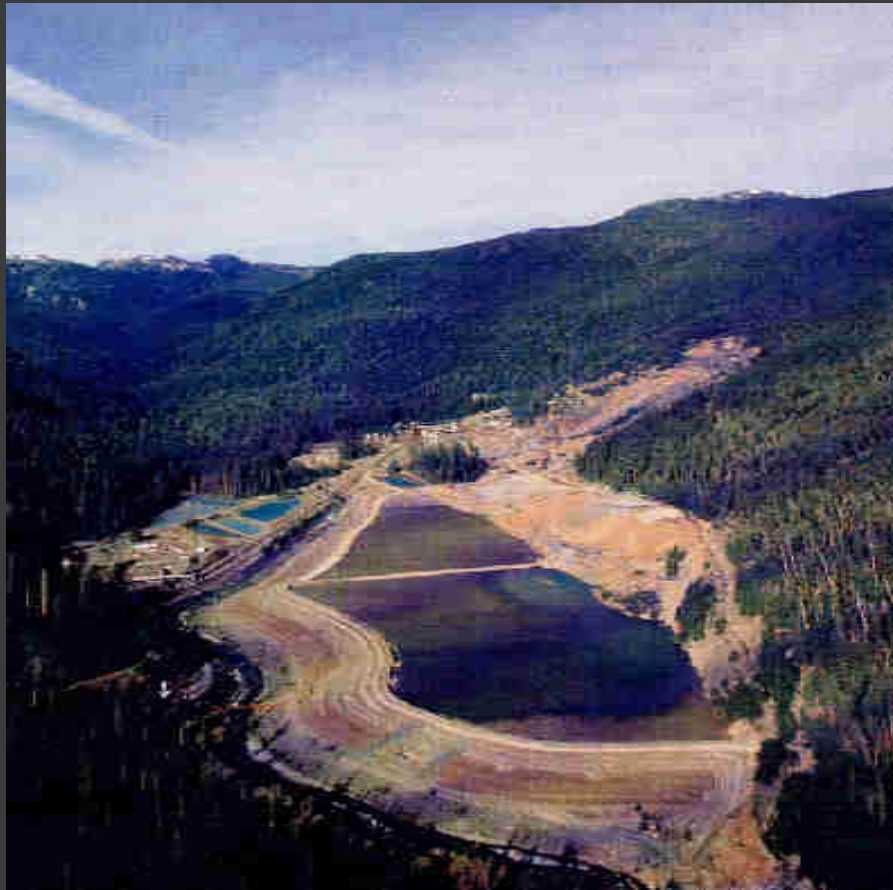
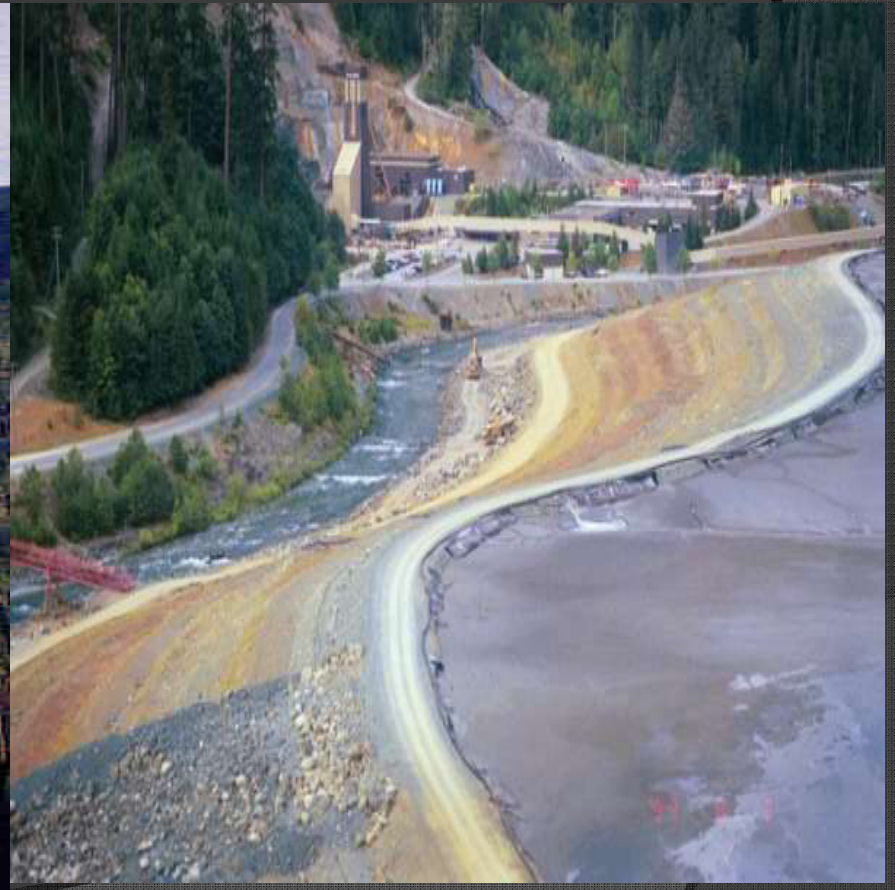
LAND BASED TAILINGS DEPOSITION 1984 - 2003

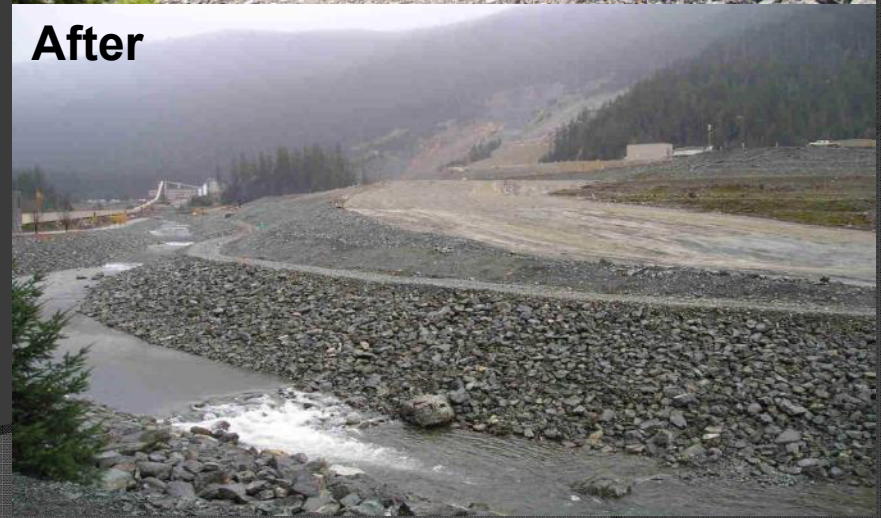
SEISMIC UPGRADE OF TDF 1999 - 2009

- Realigned of Myra Creek
- Dynamic compaction of seismic berm foundation soils
- Upgraded under drain system
- Buttress with PAG rock core, NAG rock “shell”
- Fills placed and compacted in approx. 0.5 m lifts
- Ongoing in staged manner ever since, gradually reducing risk

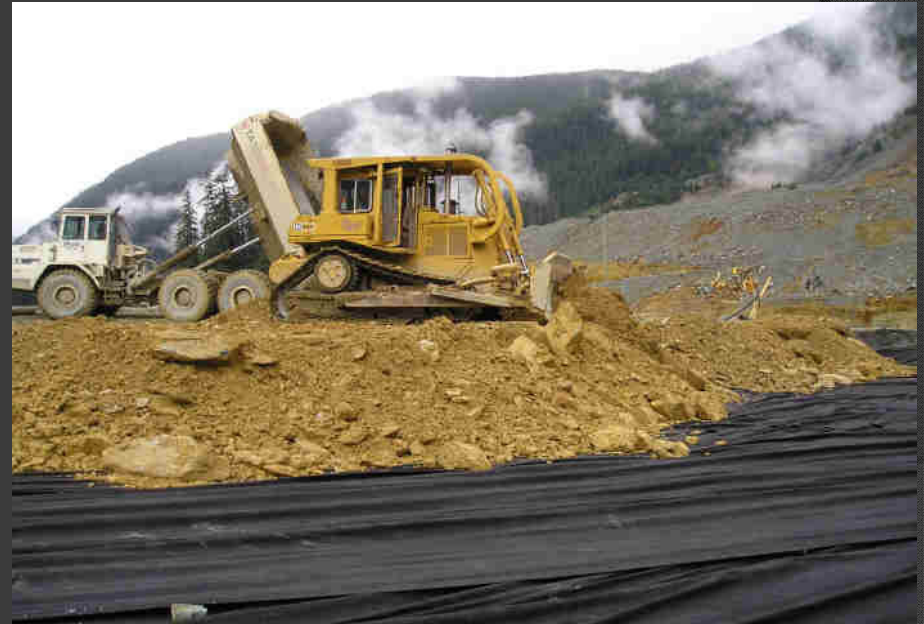
CONSTRUCTION OF THE PASTE BERM

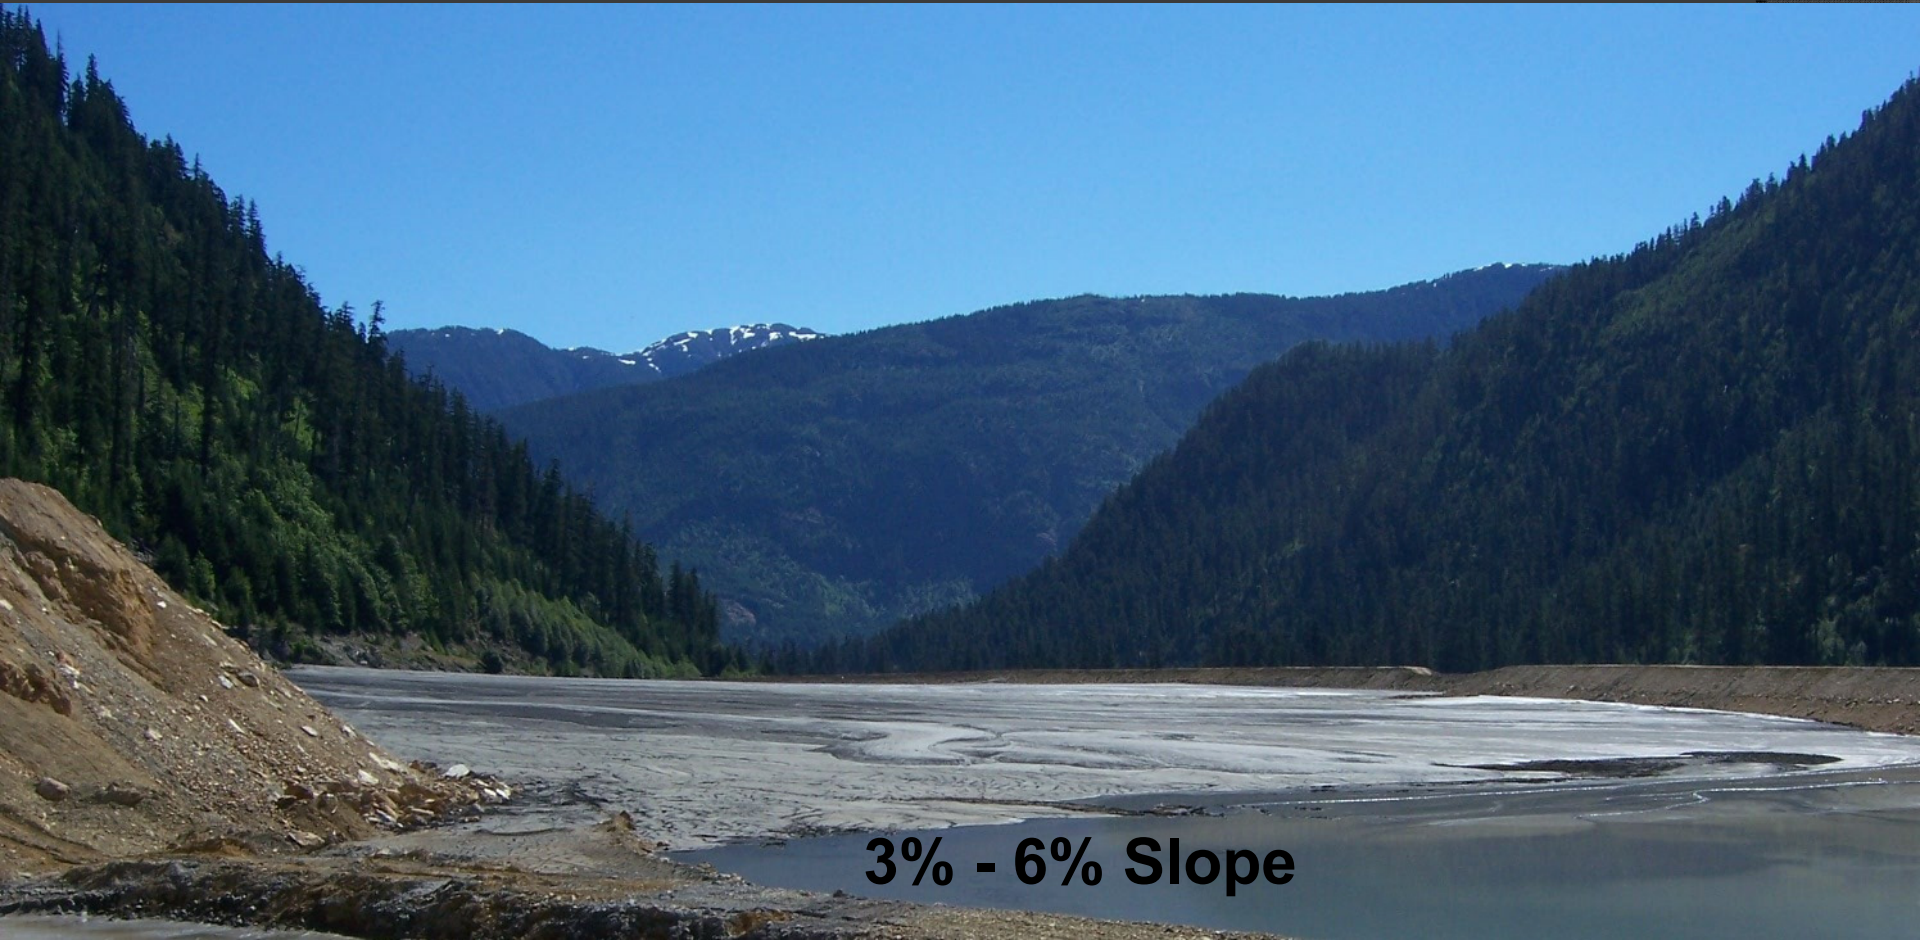
PASTE TAILINGS SLOPE

3% - 6% Slope

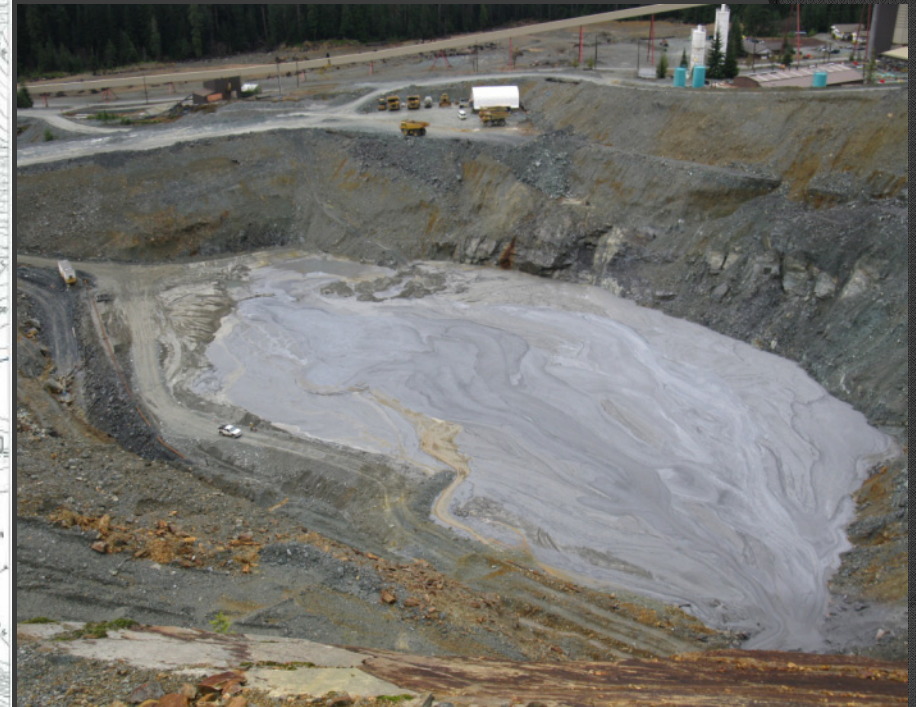
Plan of the Ultimate Lynx Paste Storage Facility

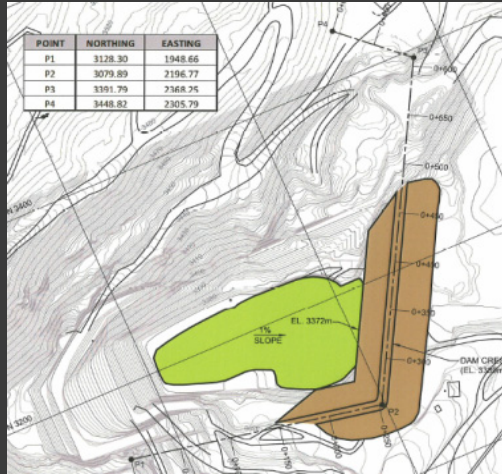
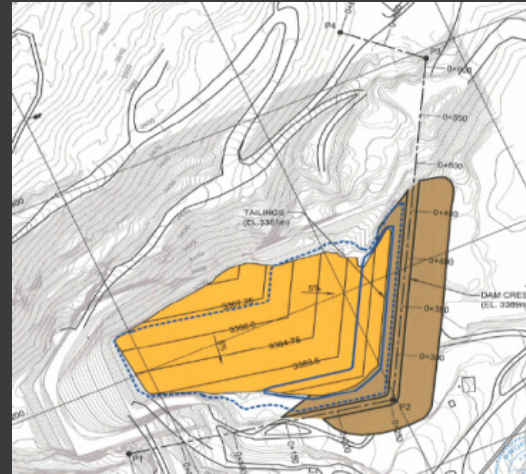
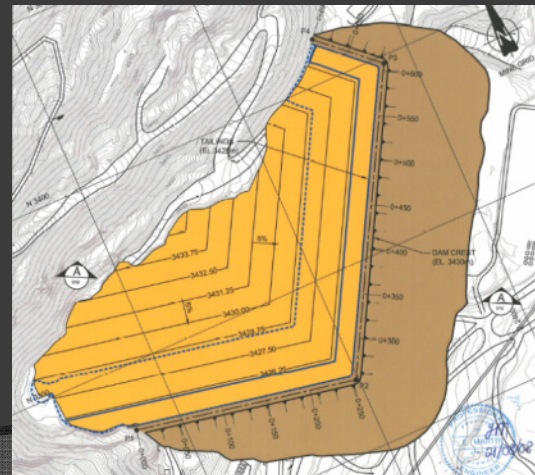
PROGRESSION OF THE LYNX TDF DEVELOPMENT

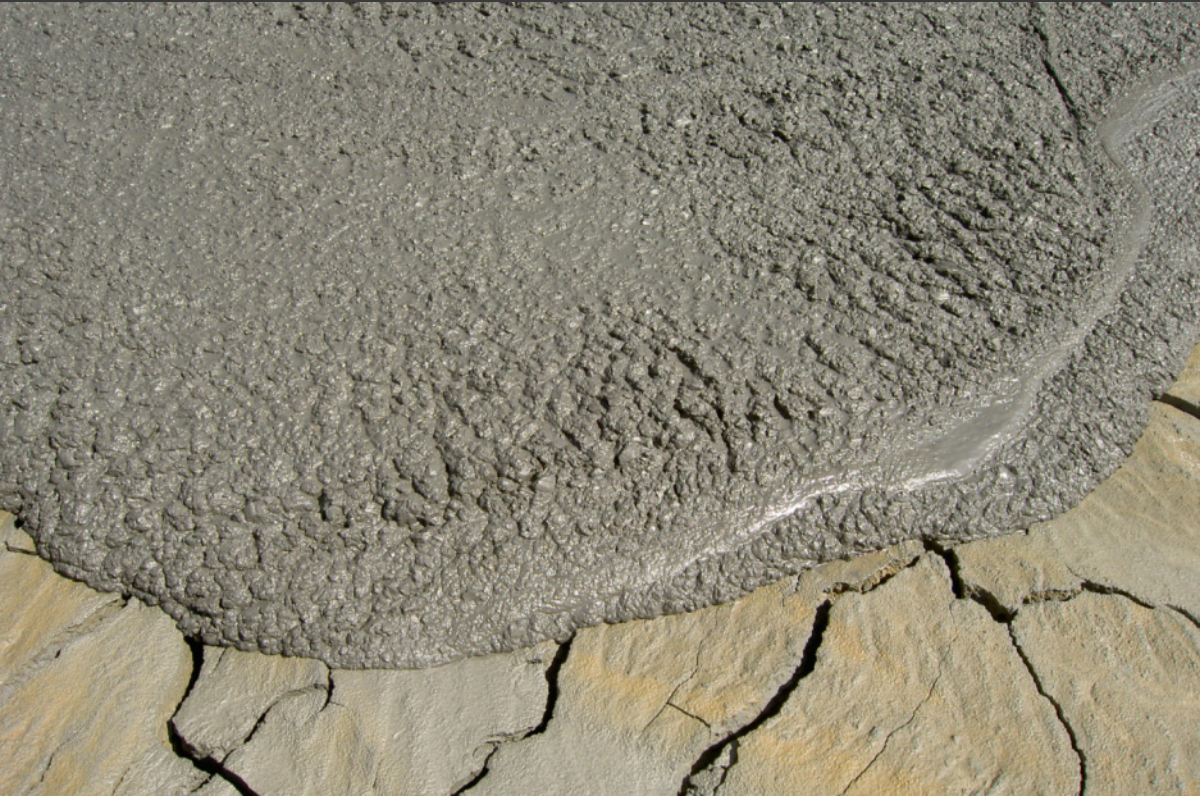
CEMENTED PASTE IN LYNX TDF

- Paste typ. 60-65% solids by weight
- Further consolidation has been observed

Paste Mix – 0.033 parts cement : 1 part dry tailings solids : 0.63 parts water

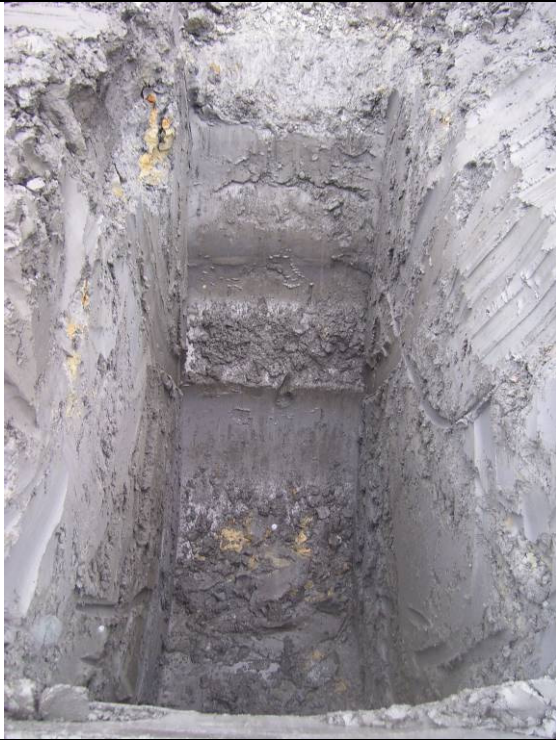
Looking north at the test pit after 3.5 hours. Test pit depth is 6 m. Width is approximately 1.3 m (width of digging bucket).

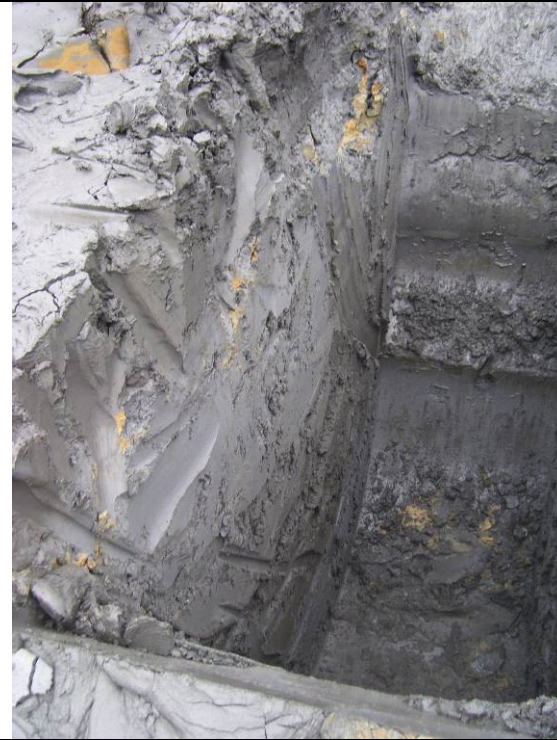
West wall of the test pit looking north after 3.5 hours.

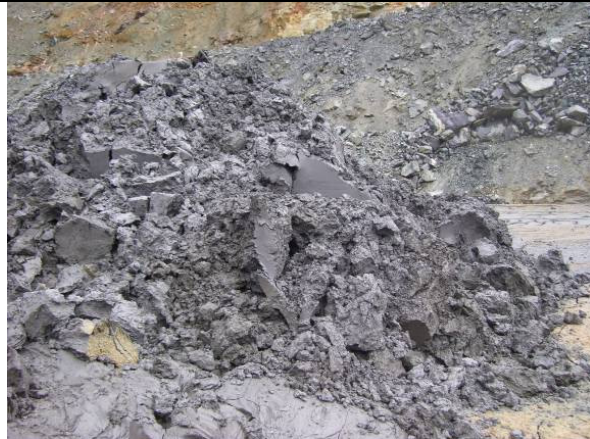
Pile of excavated material after 3.5 hours. Note the cohesion within the material, with no indications of liquefaction-type behaviour under high strains imposed by the excavation process.

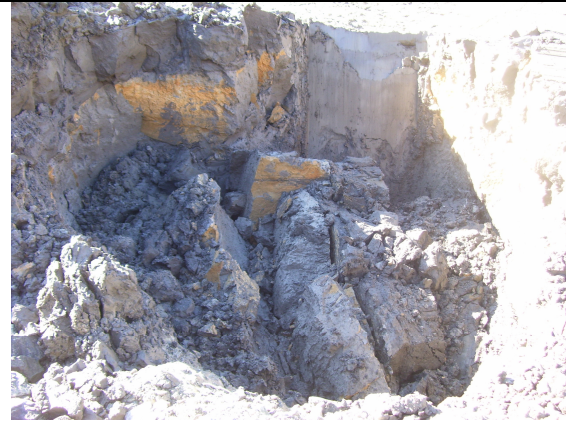
Collapsed test pit, June 10. Note the cohesion within the mass, with no indications of liquefaction-type behaviour.
