# Comparative Analysis of Defect Leakage Rates at Geomembrane-Lined Cover Systems in the Sydney Coalfield

Public Services and  
Procurement Canada

*BC MEND MLARD Workshop*

*9<sup>th</sup> December 2021*

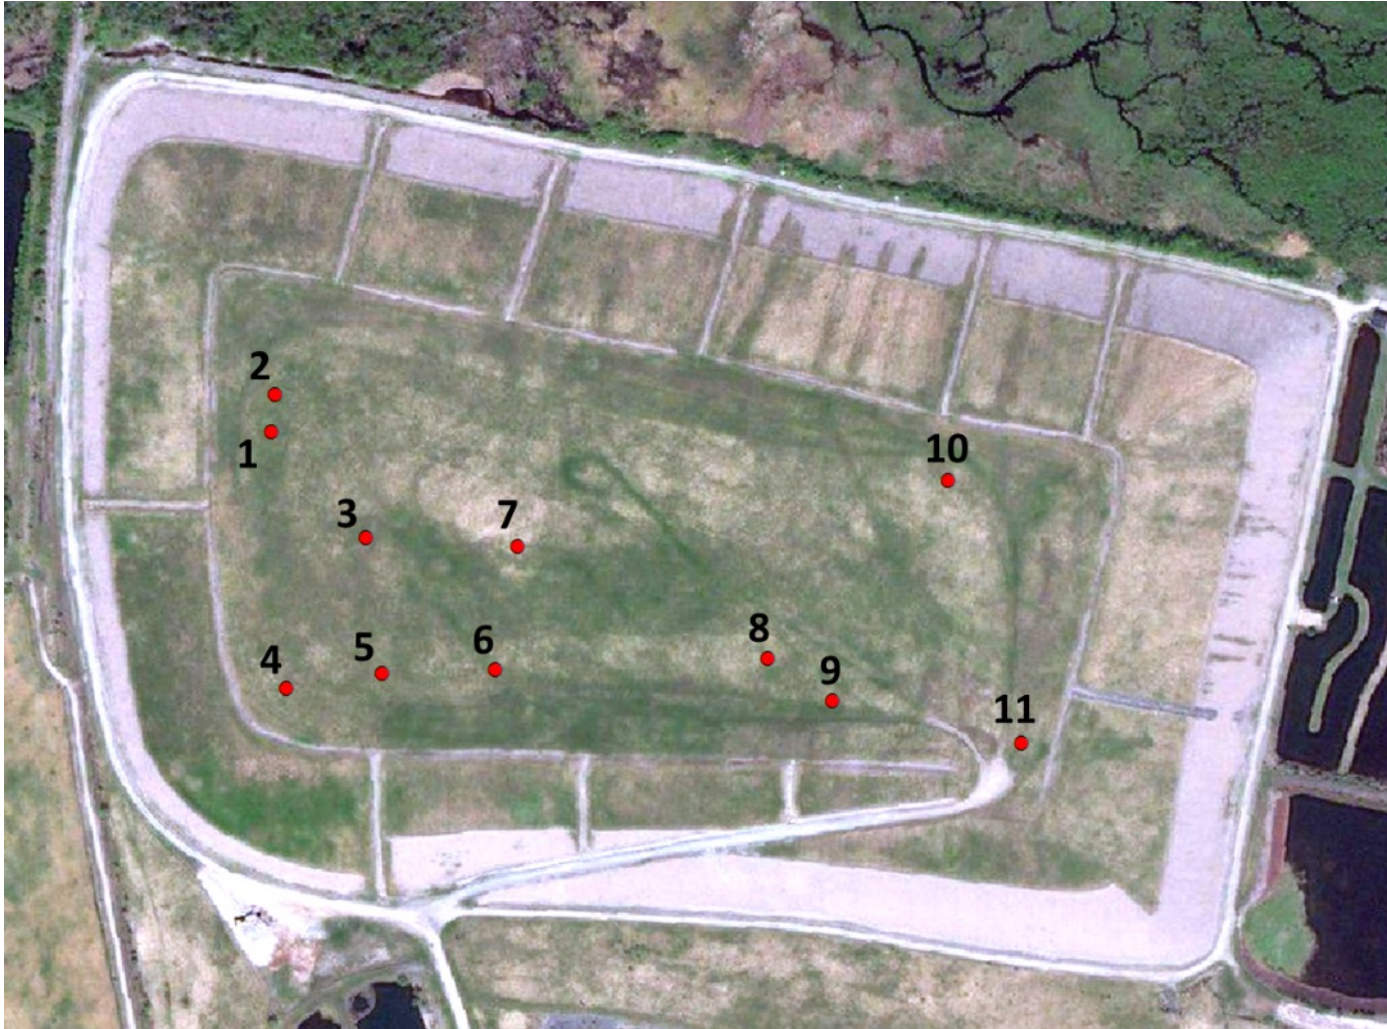
## Victoria Junction – Summary of Plateau Defects

*Total Defects = 26*
